LU-24-027 IN-PERSON TESTIMONY

RE: LU-24-027 Reconsideration Testimony

EPA INSPECTION REPORTS – VIOLATIONS TRACKER

EPA Inspection Reports on Republic Owned Landfills

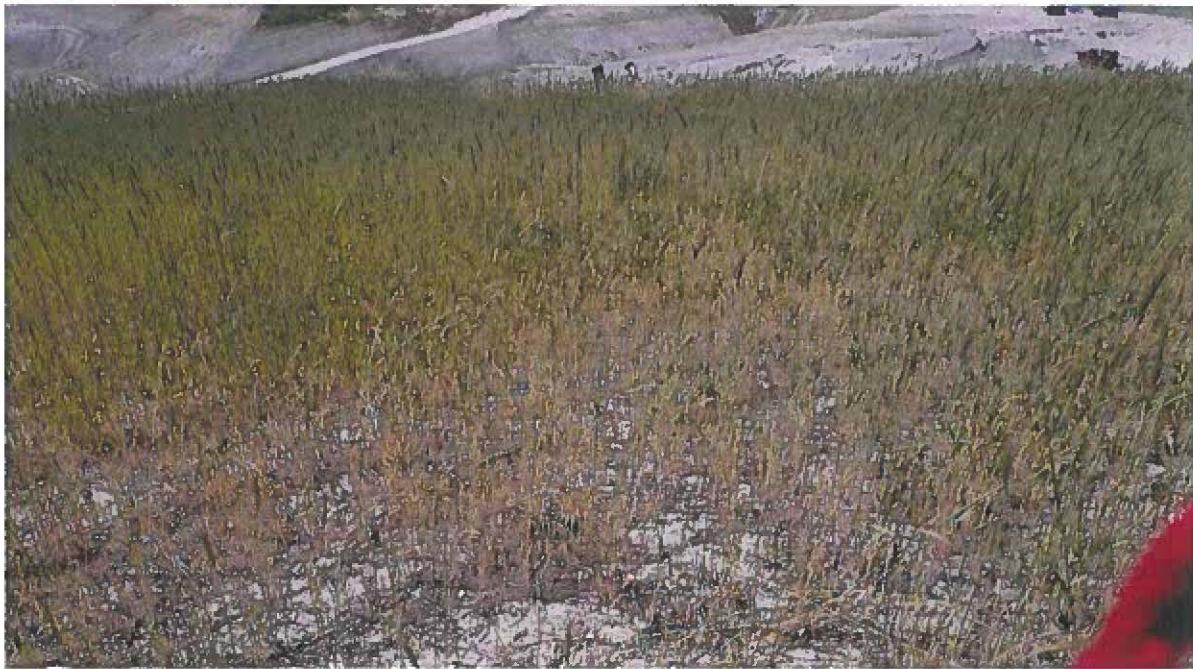
Methane exceedance of 1,290 ppm found at Land Comp Landfill (see [Appendices page 1, 2, digital image log](#)): [Image](#)

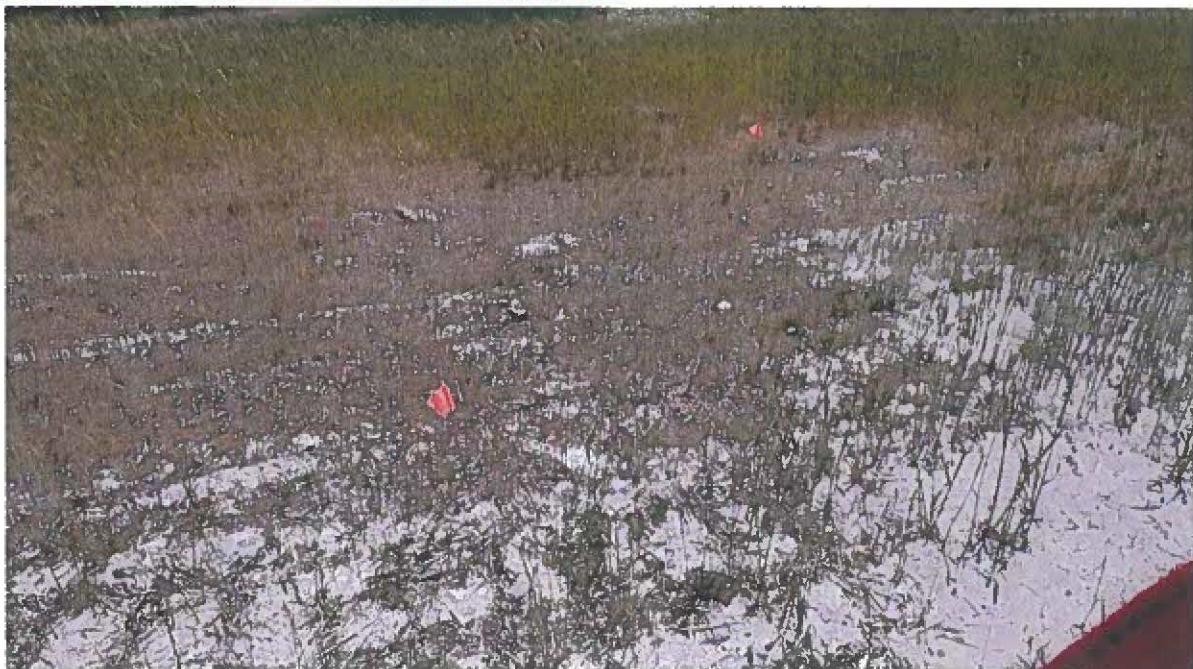
Dead vegetation area, exceedances 11 (3,033 ppm) and 12 (1,200 ppm) found (see [Appendices page 1, 2, digital image log](#)): [Image](#)

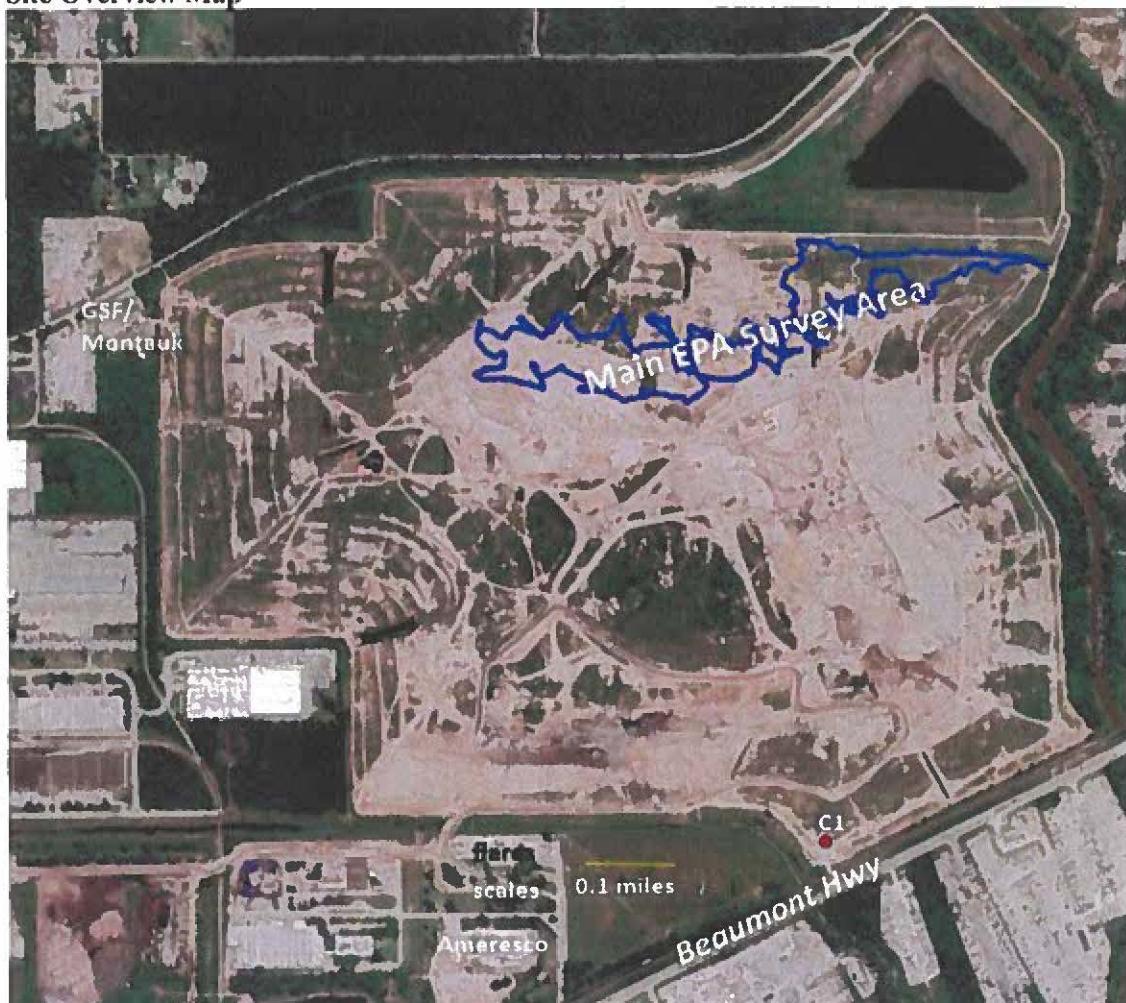
Site Overview Map

"EPA monitoring focused on part of the northern area of the Landfill, an area that had not seen any recent construction or waste deposition activity, covering an area of less than 40 acres. See Appendix C for maps. **EPA inspectors identified 55 total points above 500 ppm methane. Only two points were not able to be confirmed.**" (page 3)

"While driving around the landfill to take upwind and downwind measurements, EPA noted an elevated area of methane. This was a widespread area of exceedance by ES-2, with exceedances at gaskets and from the base and top of nearby survey posts.

In the main area of SEM survey on the northern portion of the Landfill, exceedances were found primarily at penetrations and areas of erosion/exposed waste." (page 4)

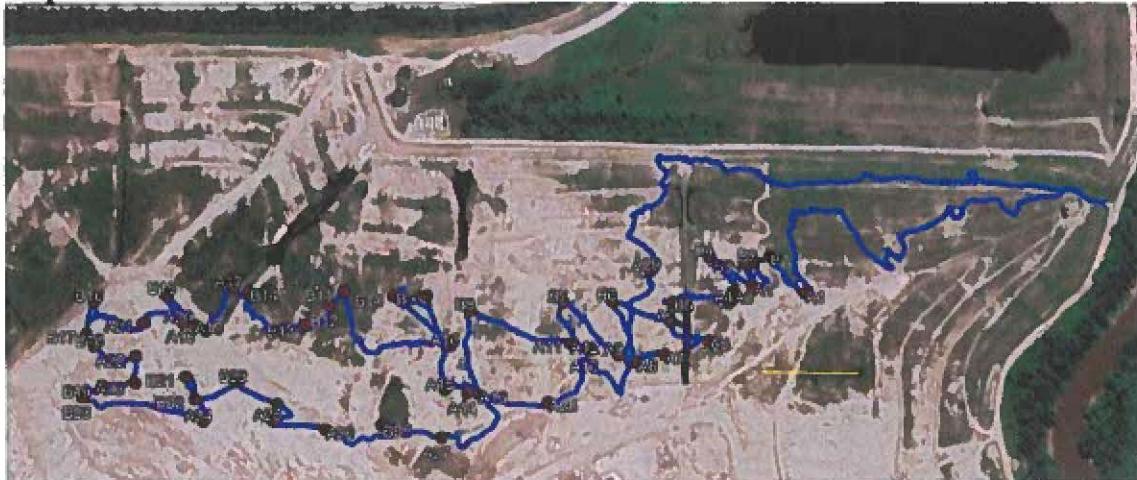
Map of Detected Exceedances

- **EPA noted the disparity between the number of exceedances they had found compared with the reviewed recent SEM surveys, indicating possible concerns with the quality of the SEM surveys**
- **EPA noted that erosion and exposed waste was seen across the survey area**
- **EPA noted that some of the pneumatic pump outlets were venting landfill gas (and condensate), and that the carbon cannisters being utilized did not effectively control the Emissions" (page 6)**

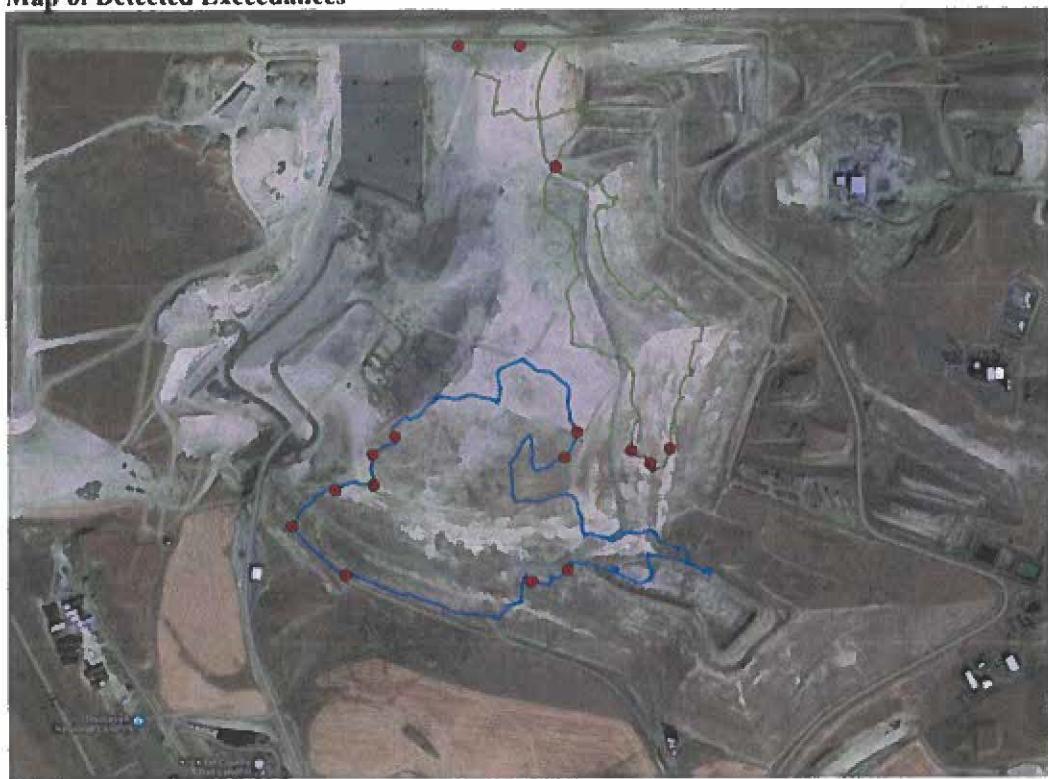
Map of Detected Exceedances

Daniel Heins expressed as a concern that despite Republic having never found any SEM exceedances in its past 5 years of quarterly monitoring, including a full year of checking all penetration points, EPA identified 16 points in exceedance of 500 ppm, including 5 points above 10,000 ppm, indicating potential concerns with Republic's SEM/Method 21 procedures." (page 6)

Flag #	Reading (ppm/%)	Description	Latitude	Longitude
1	2400	T18A1, where horizontal exits dirt	45.81478218	-120.1825788
2	5%	T18-A4, where horizontals exit dirt (two animals burrows)	45.81478541	-120.1807079
3	1200	17VO3, base of well	45.81219925	-120.1796552
4	730	10V06	45.80618911	-120.1762359
5	2200	A10TPO3, valve for header	45.80587112	-120.1768405
6	2%	Abandoned well(?) uphill from 10R16 (small open pipe and base of larger pipe)	45.80615	-120.177414
7	3400	LC058, where exits dirt, also un-gasketed cap	45.80456151	-120.1877082
8	1000	08V02 (base)	45.80532307	-120.1864192
9	1%	Pipe in ground by 8V08	45.8054303	-120.185231
10	1500	08V11 at base	45.80608553	-120.1852499
11	600	Remote wellhead(?) ~50' west of 9B01	45.80647645	-120.1845794
12	1200	10V19 at base	45.80654769	-120.1790285
13	1%	6V11 at base	45.80601013	-120.1794204
14	6000	Wood covered valve box	45.80357938	-120.1793451
15	1.5%	Exposed hose coming out of dirt	45.80335383	-120.1804316

16	1000	LC057 at meeting with dirt	45.80349002	-120.1861183
