**SUBJECT:** CLEAN AIR ACT INSPECTION REPORT  
Republic Services Coffin Butte Landfill, Corvallis, OR

**Facility Name:** Republic Services Coffin Butte Landfill

**Date of Inspection:** On Site Inspection: June 23, 2022  
Virtual Conference: July 11, 2022

**Purpose of Inspection:** Surface emissions monitoring (SEM) and evaluating compliance with landfill air rules.

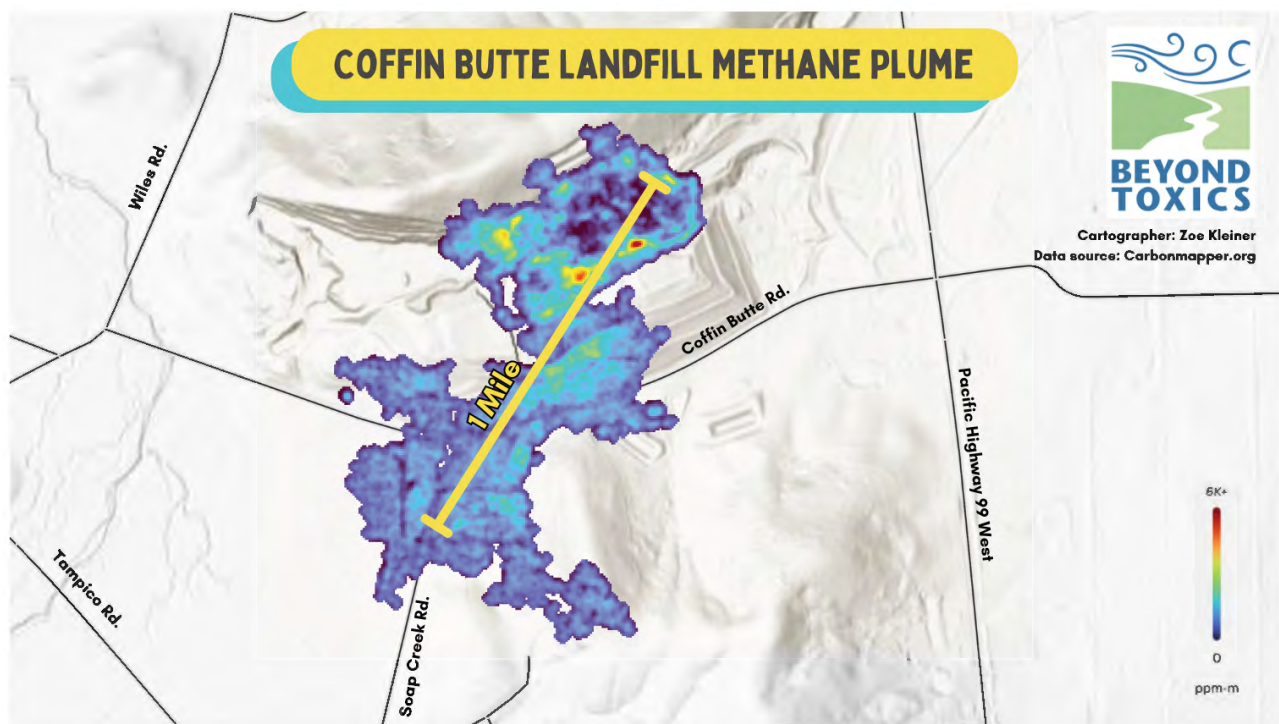
*Map Caption:* In June 2022, the EPA found over 70 instances of excessive methane emissions, including 7 leaks posing explosion or fire risks. By July 2023, Carbon Mapper detected 16 major methane plumes, one of which is shown above. Coffin Butte is still under investigation by the EPA for its methane leaks.

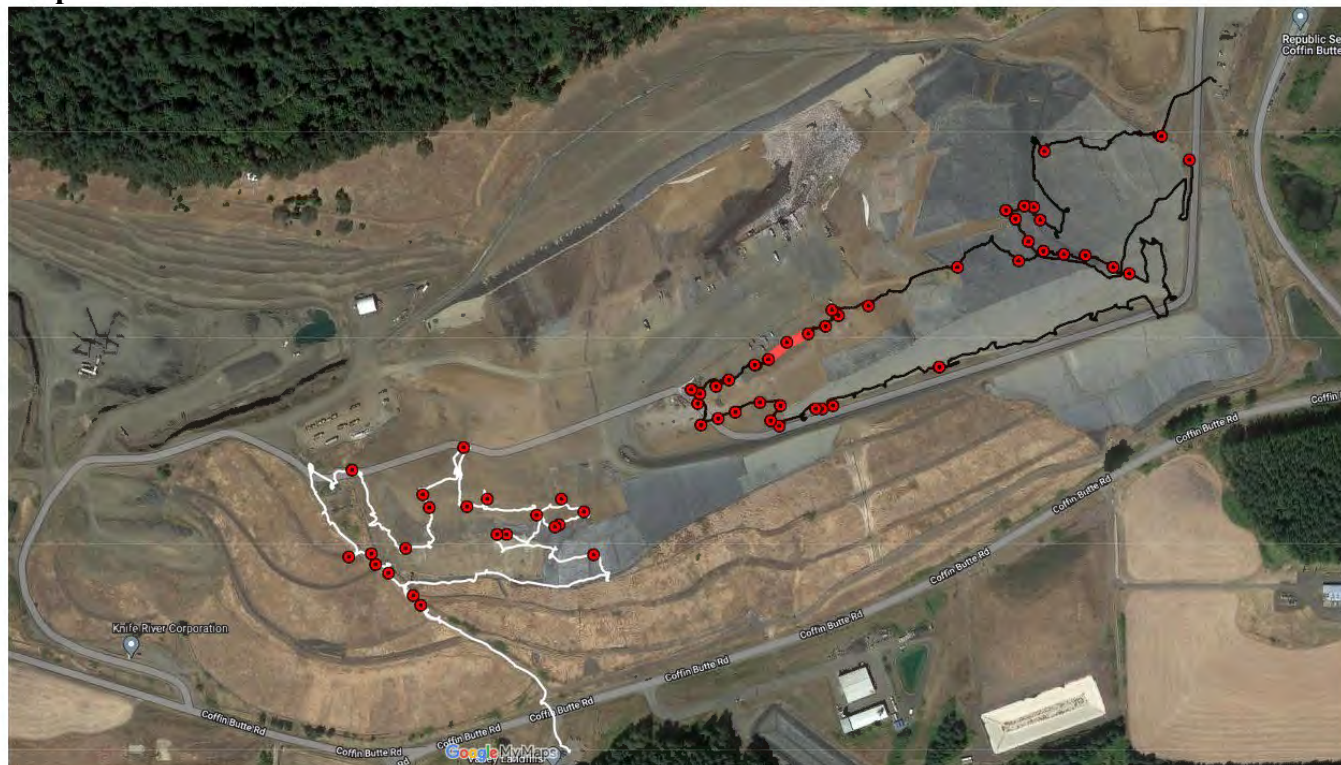
### Map of Detected Exceedances

SEM exceedance locations plotted over Google Maps satellite imagery. Approximate monitoring paths included, derived from GPS data. Morning path shown in white, afternoon in black. Line of continuous exceedance at every tarp hole between flags 52 and 54 is highlighted in red.
