Summary of the 2024 EPA Clean Air Act Inspection at Coffin  
Butte Landfill

# Clean Air Act Partial Compliance Evaluation Inspection Report

## *Valley Landfills Inc. Coffin Butte Landfill*

Inspection Date: June 21, 2024

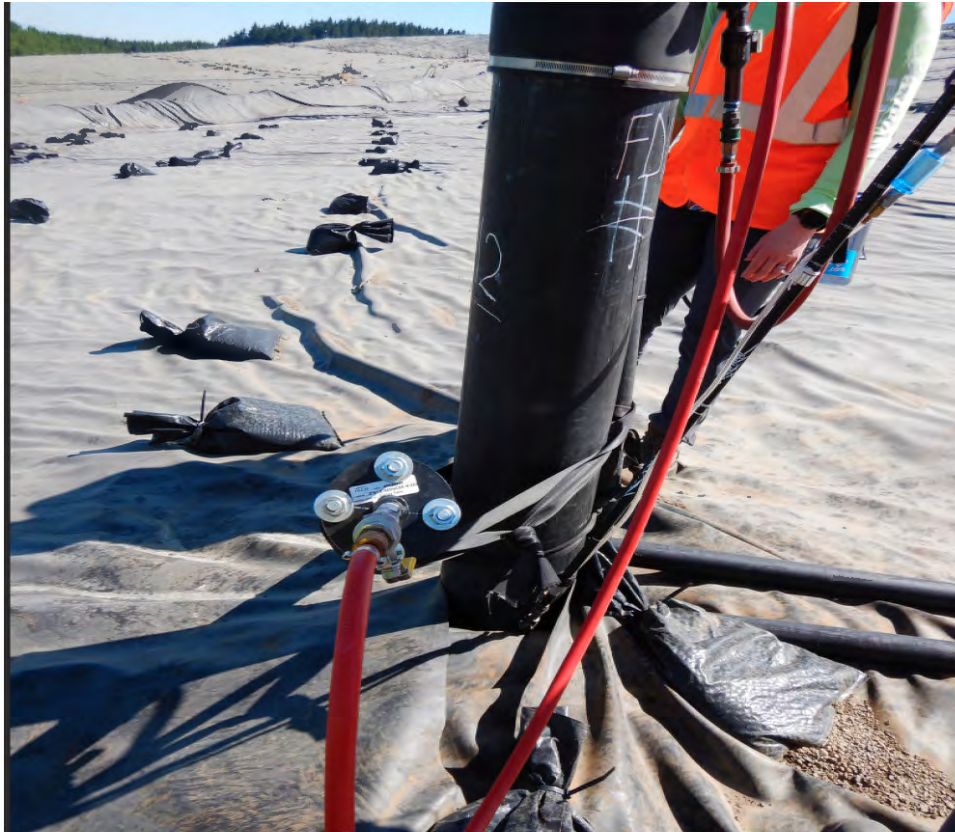
**Example 1 - 4,000 ppm Methane Exceedance at gas collection piping/equipment**

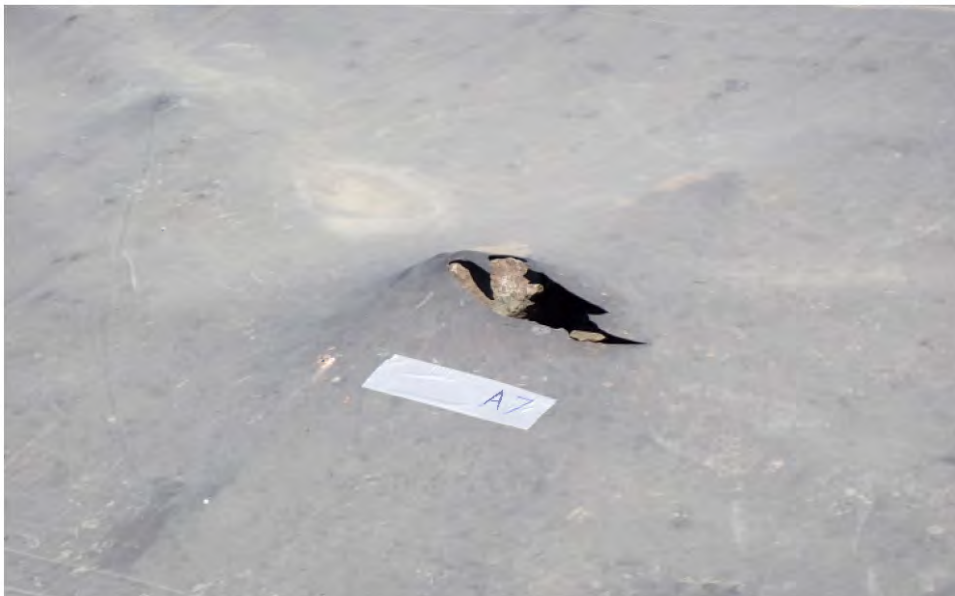
**Example 2 - 20,000 ppm Methane Exceedance from small tear in the tarp**

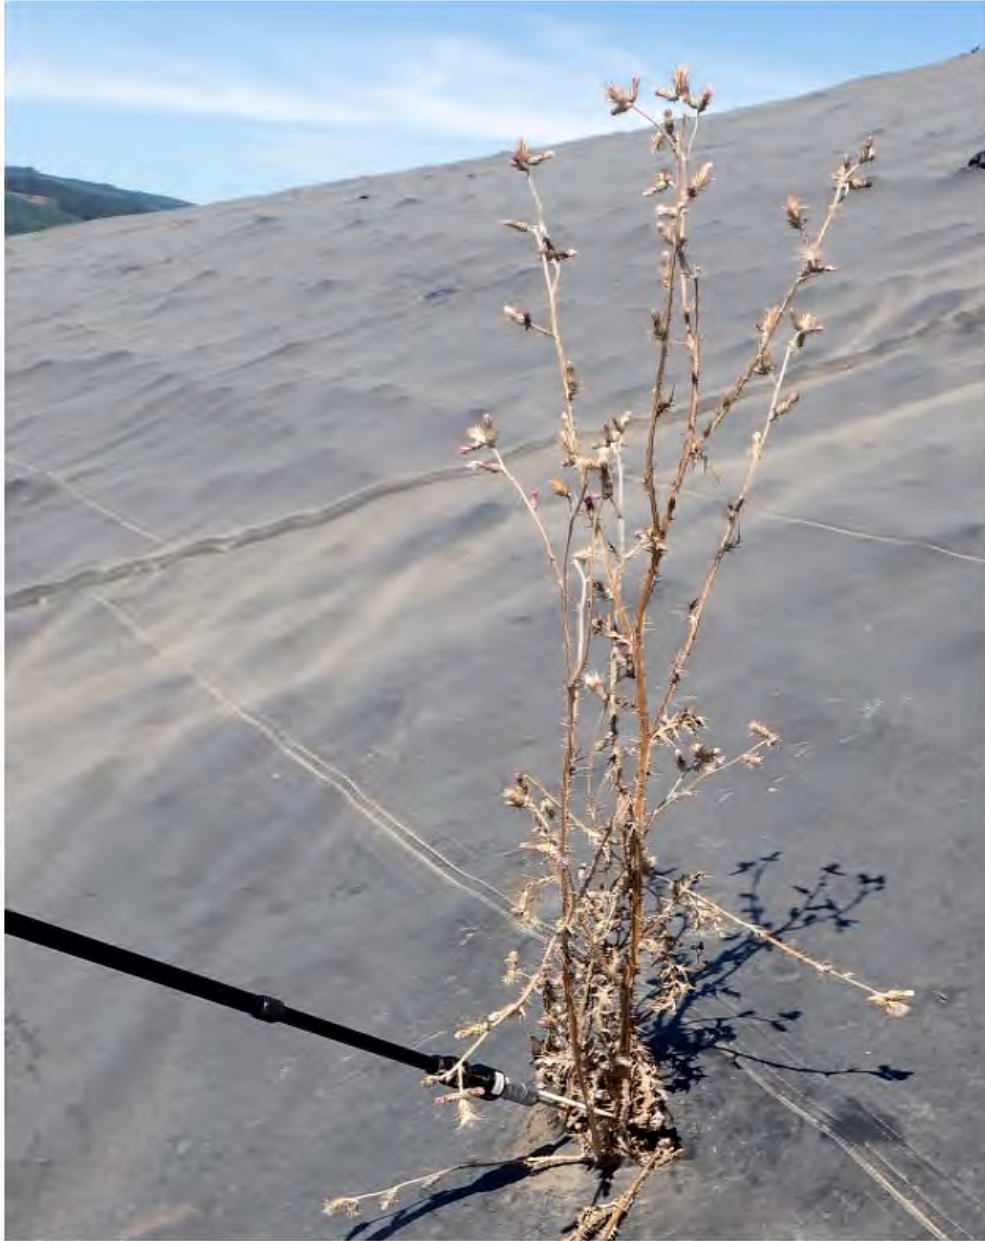
**Example 3 - 800 ppm Methane Exceedance measured where a weed punctured the tarp**

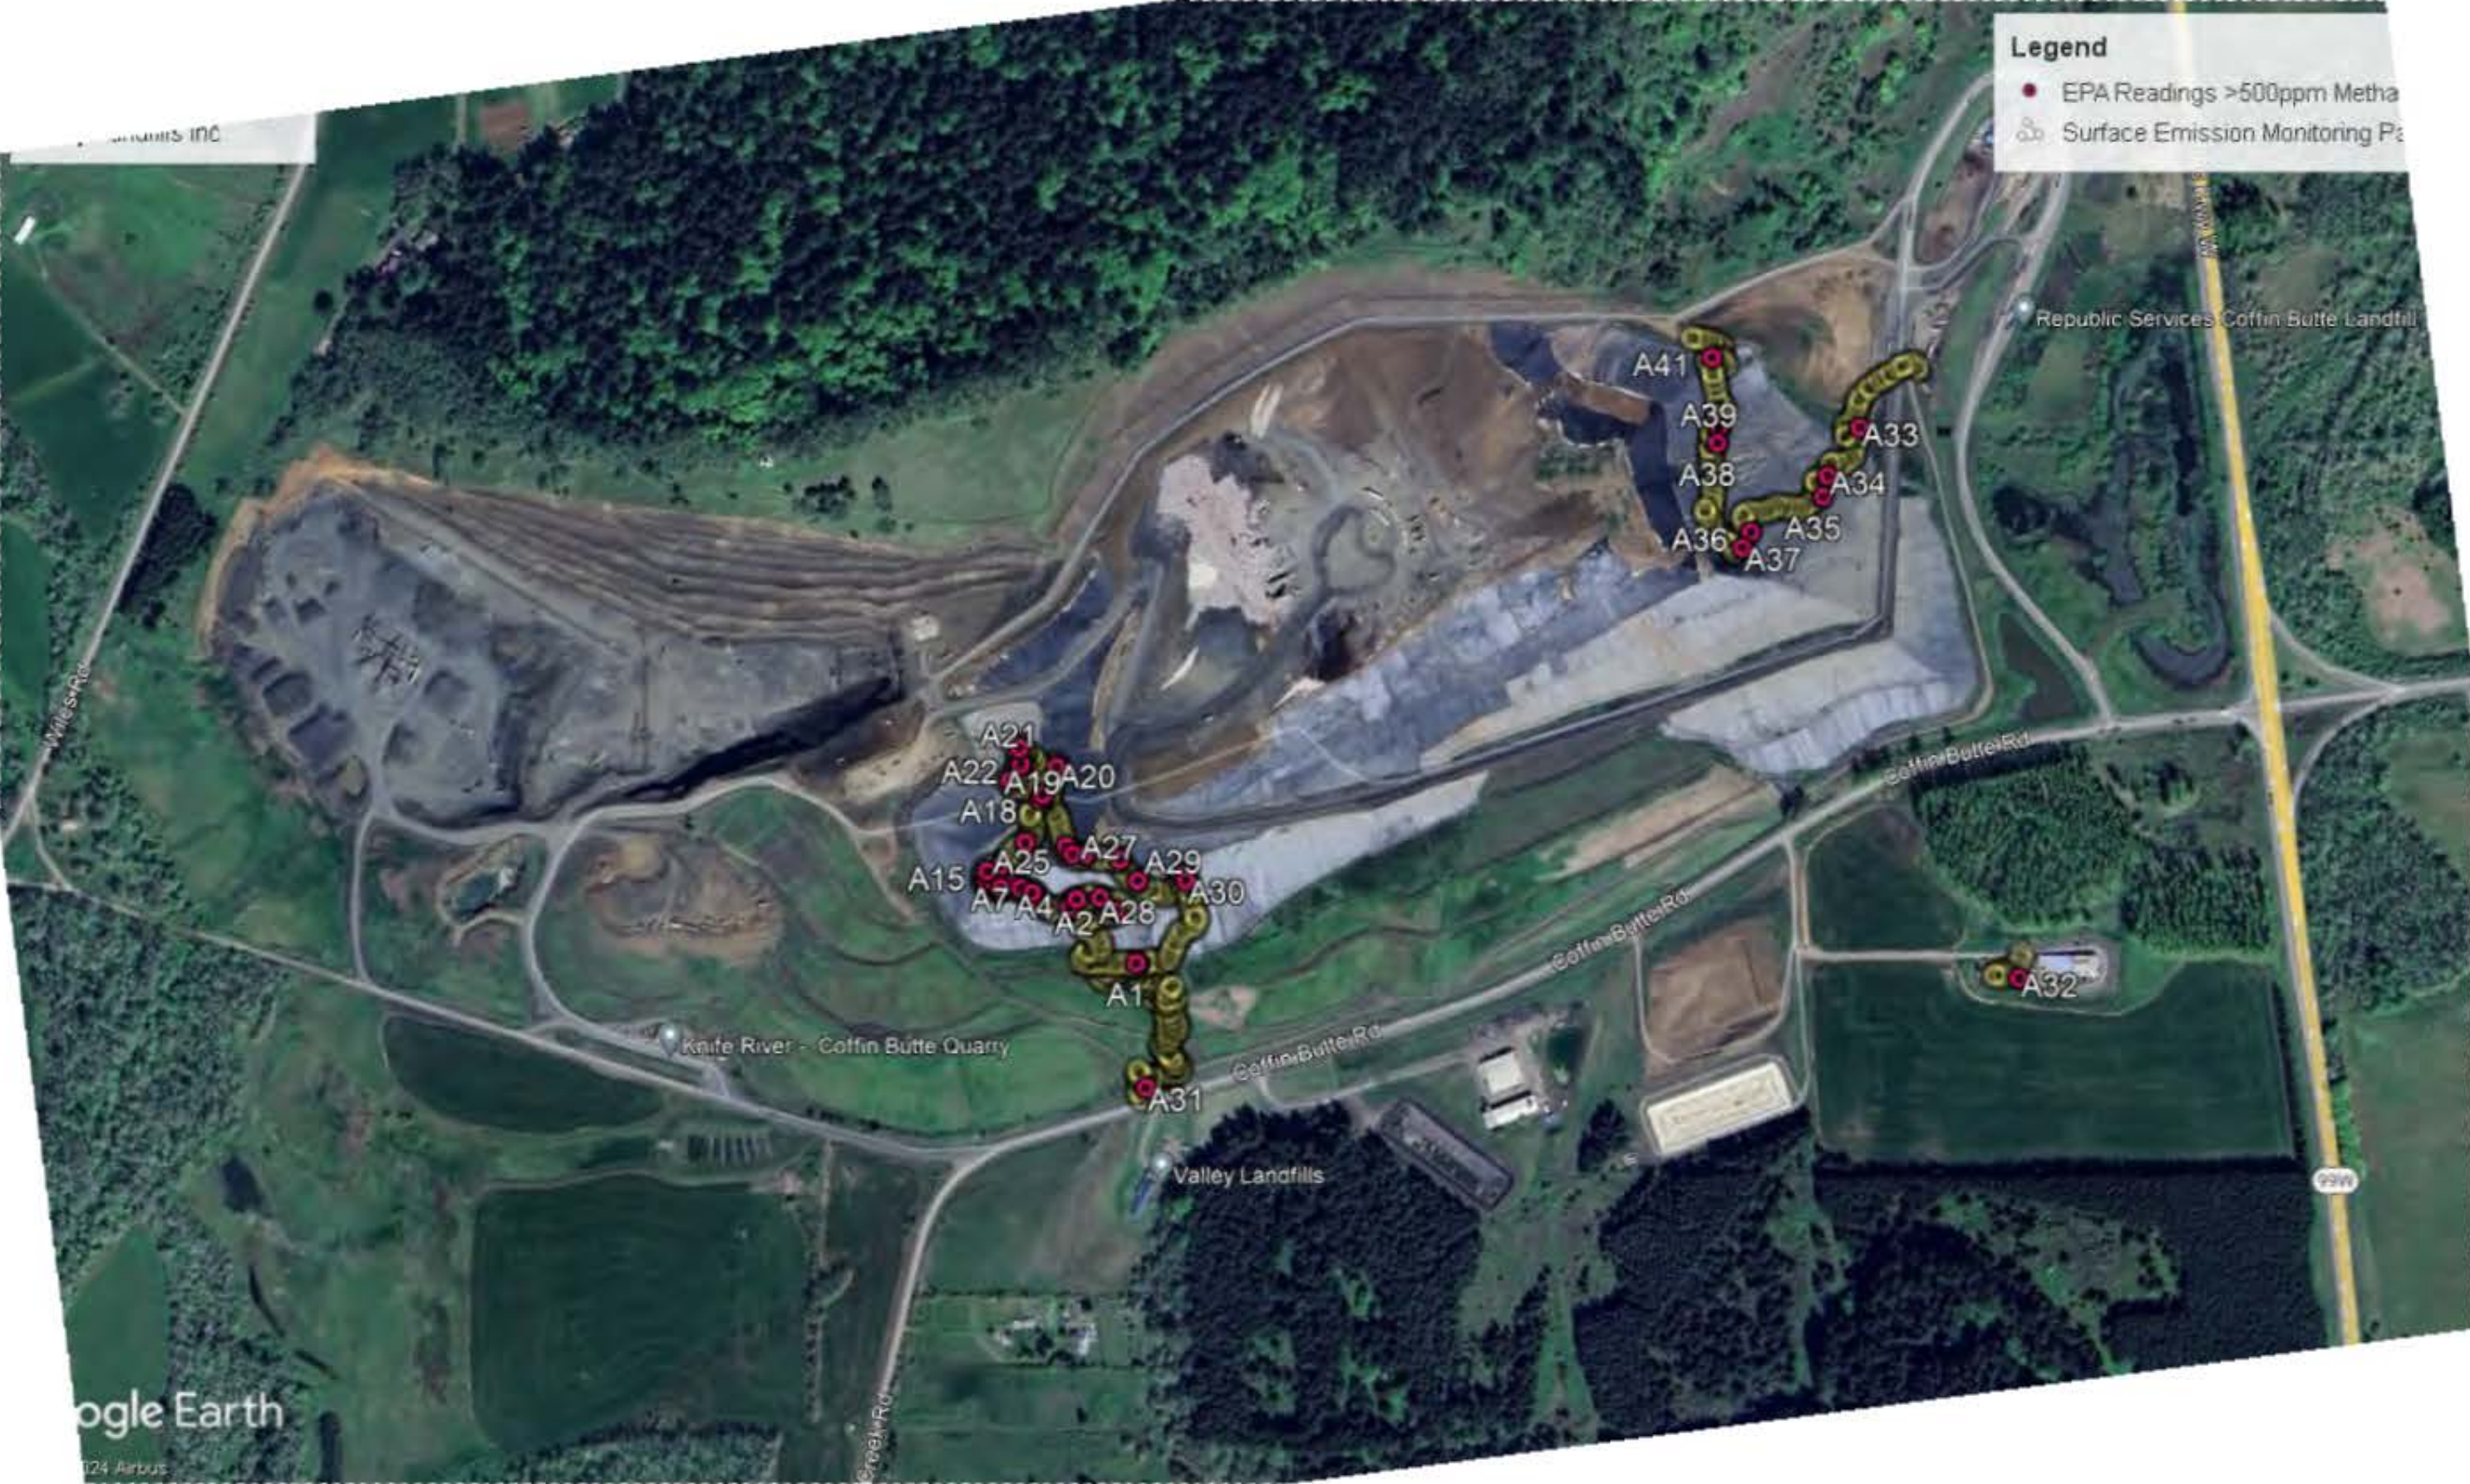
1. EPA monitored only a portion of the landfill surface and found numerous methane emissions at 500 ppm and higher, including at holes in the cover material. We identified many of the approximately 40 exceedances at locations where the cover material was damaged. Inspectors had noticed some plants growing out of the cover material near the areas where we monitored for emissions.
2. EPA monitored a flange at the flare station had methane emissions over 500ppm. The facility indicated that they were repairing this flange while we were in the opening conference.
3. One of the wellheads EPA monitored to was open to the atmosphere and the IRwin measured emissions over 500ppm.

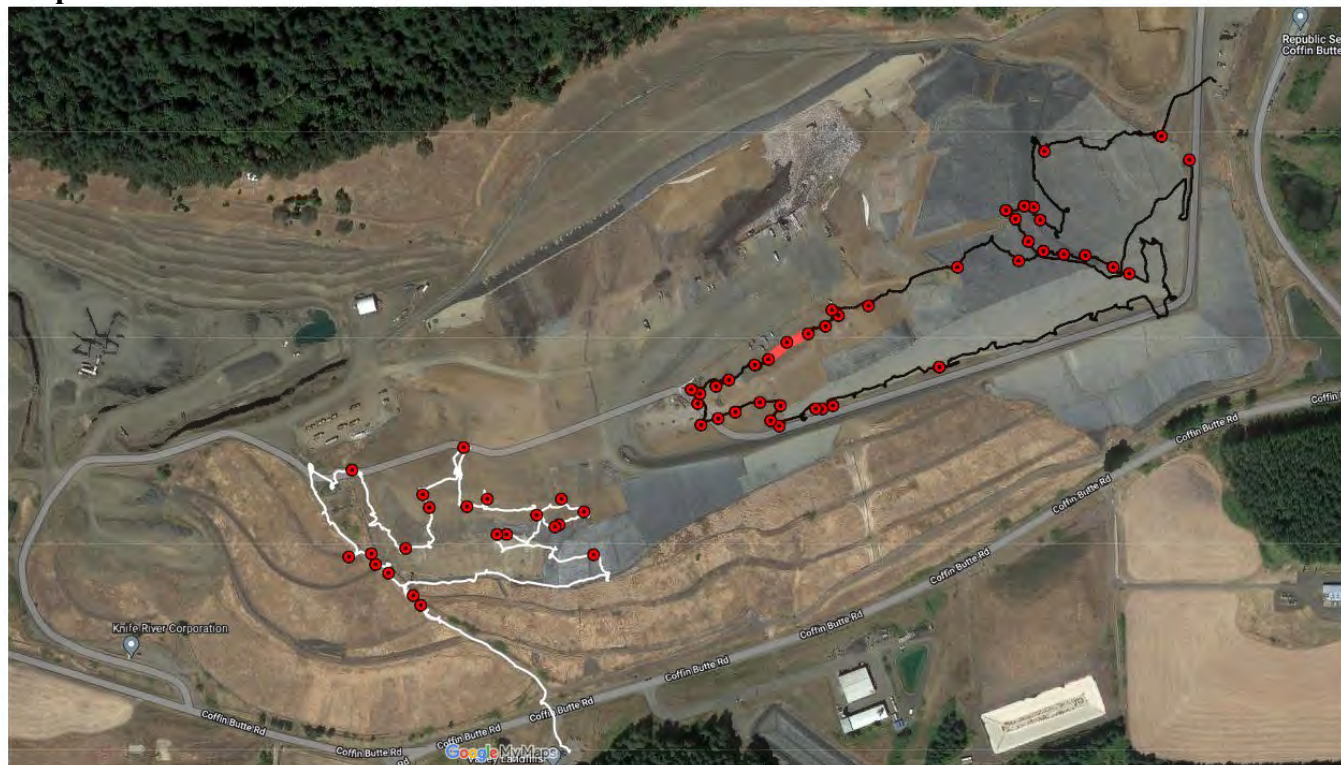
### Map of Detected Exceedances

Daniel Heins expressed concerns with the areas of tarp that were inflated with and leaking out landfill gas, as detected during the SEM, noting that in additions to compliance concerns with the surface methane standard that such an accumulation of flammable gas creates a potential safety concern.

SEM exceedance locations plotted over Google Maps satellite imagery. Approximate monitoring paths included, derived from GPS data. Morning path shown in white, afternoon in black. Line of continuous exceedance at every tarp hole between flags 52 and 54 is highlighted in red.
