**My Testimony Strongly Opposing Coffin Butte Landfill Expansion**  
**File Number LU-24-027**

**SUBJECT:** CLEAN AIR ACT INSPECTION REPORT  
Republic Services Coffin Butte Landfill, Corvallis, OR

**Facility Name:** Republic Services Coffin Butte Landfill

**Date of Inspection:** On Site Inspection: June 23, 2022  
Virtual Conference: July 11, 2022

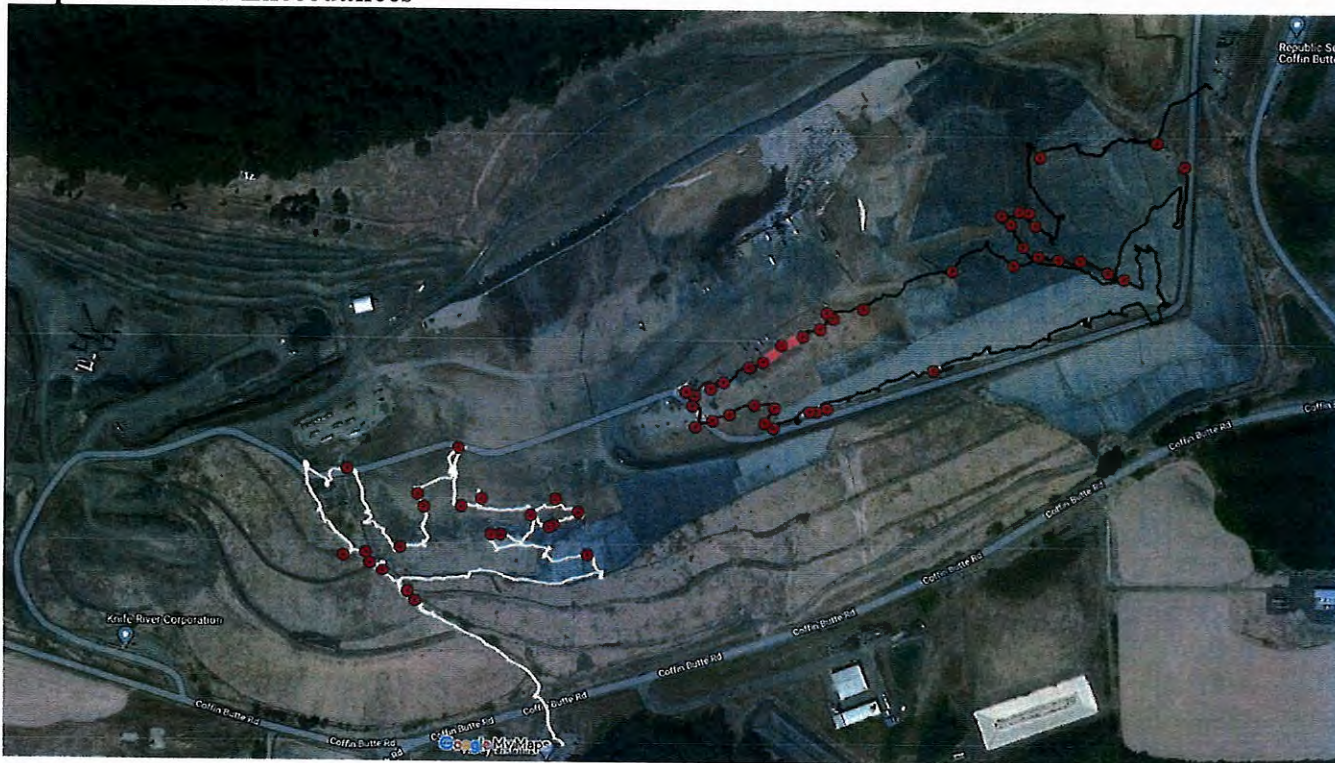
## Map of Detected Exceedances

In the morning (9:50 - 12:45), Daniel Heins conducted the monitoring with the TVA, covering a loop on the western portion of the Landfill. In the afternoon (13:30 - 17:15), he continued monitoring with the TVA, covering a loop on the eastern portion of the Landfill. Over the course of the day, Daniel Heins identified 61 points in exceedance of 500 parts per million (ppm), exhausting his supply of marking flags. Of these, 21 flagged exceedances were above 10,000

ppm. Many flagged exceedances represented clusters of exceedances at multiple points or broad areas of exceedances. Of the flagged exceedances, 26 were at or partially at gas collection wells (including both active and abandoned or decommissioned). Eight exceedances were at leachate cleanouts. Daniel Heins focused monitoring on areas under intermediate cover, though the first six exceedances were in final cover areas. During the afternoon monitoring, Daniel Heins measured multiple exceedances that continued to be above 500 ppm multiple feet in the air, with multiple feet lateral distance from the emission source, indicating substantial landfill gas plumes (flag #26, 46, and 51).

Flag #51 was by a broad area where the tarp was visibly inflated with gas. The tarp was not moving in the wind, it looked to be being pushed out steadily over a wide area towards the top of the south slope on the central area of the landfill, being held down by straps, cover anchors, and sandbags. Neither Daniel Heins nor Phil Caruso could identify any place where the wind could be lifting under the tarps, as the tarp edges were sandbagged and staked down. Daniel Heins measured a concentration of 2% at flag #51 before pulling away to avoid maxing out his instrument. He measured the methane concentration to be 2000 ppm at 3' in the air at this location, indicating a plume of gas coming out from the inflated tarp area. Along the top of this section of tarp, from flag #52 to #54, every post or tarp hole Daniel Heins monitored exceeded the surface methane standard, with readings of up to 7% shown before the instrument maxed out.

SEM exceedance locations plotted over Google Maps satellite imagery. Approximate monitoring paths included, derived from GPS data. Morning path shown in white, afternoon in black. Line of continuous exceedance at every tarp hole between flags 52 and 54 is highlighted in red.
