**Testimony of Roxana Kaferly**  
**Strongly Opposing Coffin Butte Landfill Expansion**  
**File Number LU-24-027**

**SUBJECT:** CLEAN AIR ACT INSPECTION REPORT  
Republic Services Coffin Butte Landfill, Corvallis, OR

**Facility Name:** Republic Services Coffin Butte Landfill

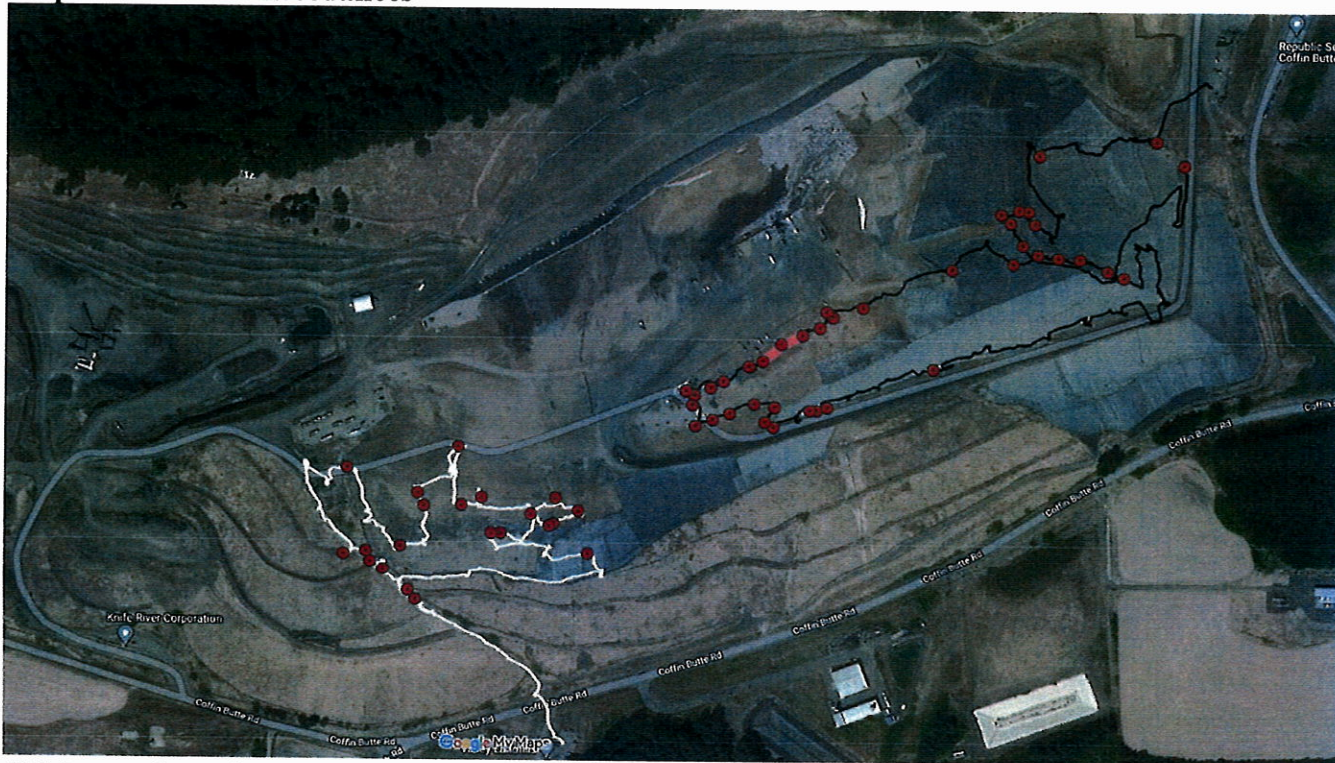
## Map of Detected Exceedances

In the morning (9:50 - 12:45), Daniel Heins conducted the monitoring with the TVA, covering a loop on the western portion of the Landfill. In the afternoon (13:30 - 17:15), he continued monitoring with the TVA, covering a loop on the eastern portion of the Landfill. Over the course of the day, Daniel Heins identified 61 points in exceedance of 500 parts per million (ppm), exhausting his supply of marking flags. Of these, 21 flagged exceedances were above 10,000

ppm. Many flagged exceedances represented clusters of exceedances at multiple points or broad areas of exceedances. Of the flagged exceedances, 26 were at or partially at gas collection wells (including both active and abandoned or decommissioned). Eight exceedances were at leachate cleanouts. Daniel Heins focused monitoring on areas under intermediate cover, though the first six exceedances were in final cover areas. During the afternoon monitoring, Daniel Heins measured multiple exceedances that continued to be above 500 ppm multiple feet in the air, with multiple feet lateral distance from the emission source, indicating substantial landfill gas plumes (flag #26, 46, and 51).

Flag #51 was by a broad area where the tarp was visibly inflated with gas. The tarp was not moving in the wind, it looked to be being pushed out steadily over a wide area towards the top of the south slope on the central area of the landfill, being held down by straps, cover anchors, and sandbags. Neither Daniel Heins nor Phil Caruso could identify any place where the wind could be lifting under the tarps, as the tarp edges were sandbagged and staked down. Daniel Heins measured a concentration of 2% at flag #51 before pulling away to avoid maxing out his instrument. He measured the methane concentration to be 2000 ppm at 3' in the air at this location, indicating a plume of gas coming out from the inflated tarp area. Along the top of this section of tarp, from flag #52 to #54, every post or tarp hole Daniel Heins monitored exceeded the surface methane standard, with readings of up to 7% shown before the instrument maxed out.

SEM exceedance locations plotted over Google Maps satellite imagery. Approximate monitoring paths included, derived from GPS data. Morning path shown in white, afternoon in black. Line of continuous exceedance at every tarp hole between flags 52 and 54 is highlighted in red.
