RE: LU-24-027

Testimony in response to ODEQ Pre-Enforcement Notice (PEN) of Nov. 6, 2025
Paul Nietfeld, Benton County resident

Summary

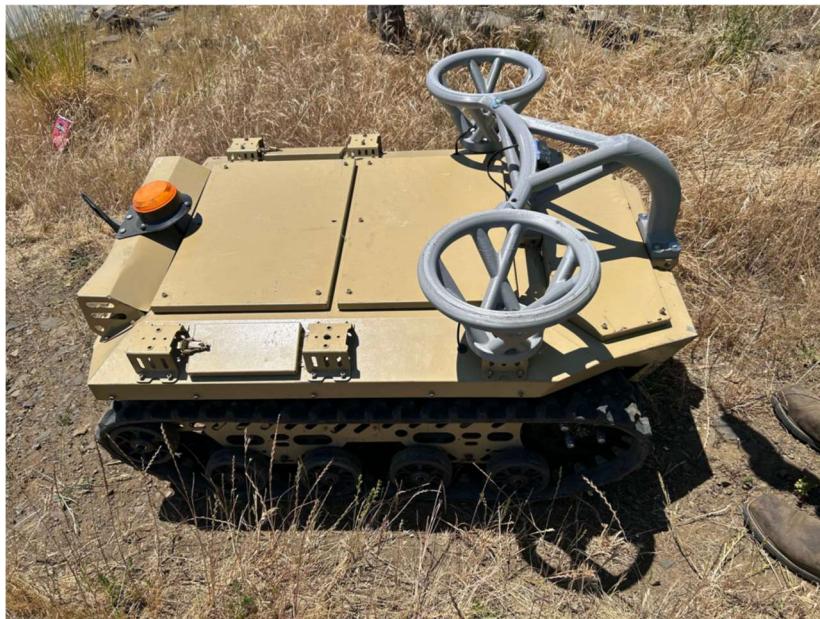
Rover methane sampling

The self-propelled “Rover” methane measuring system used in June and July 2025:

In June and July of 2025 the landfill operator employed a novel self-propelled methane measuring device identified as the “Rover.” This device was used to traverse sections of the landfill typically avoided by the normal test procedure and discovered 66 leaks in excess of 500 ppm. The normal manual search reported only 9 leaks in excess of 500 ppm for this measurement period. See the Rover Methane Sampling section below for further detail on the Rover device and see the Coffin Butte Landfill Semi-Annual Report 2025 (file Coffin_Butte_ODEQ_SAR_Rpt_2025.pdf, attached) for measurement data.

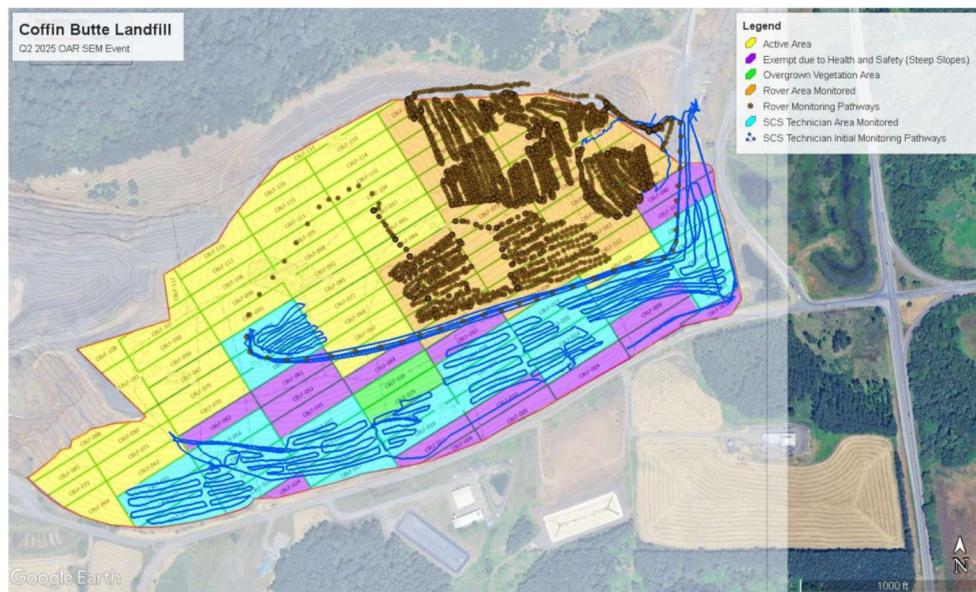
**Second Quarter 2025
Initial Surface Emissions Monitoring Pathway
Coffin Butte Landfill, Corvallis, Oregon**

The Rover track for June and July 2025 methane emission measurements (tracks shown in brown). Standard (walking) tracks shown in blue.

The dramatic increase in large-volume methane leaks discovered by the Rover indicate that the standard methane monitoring performed by the operator is inadequate and points to the need for more effective technologies such as drone monitoring as recommended by ODEQ (PEN, Page 9, Corrective Action Request #1).

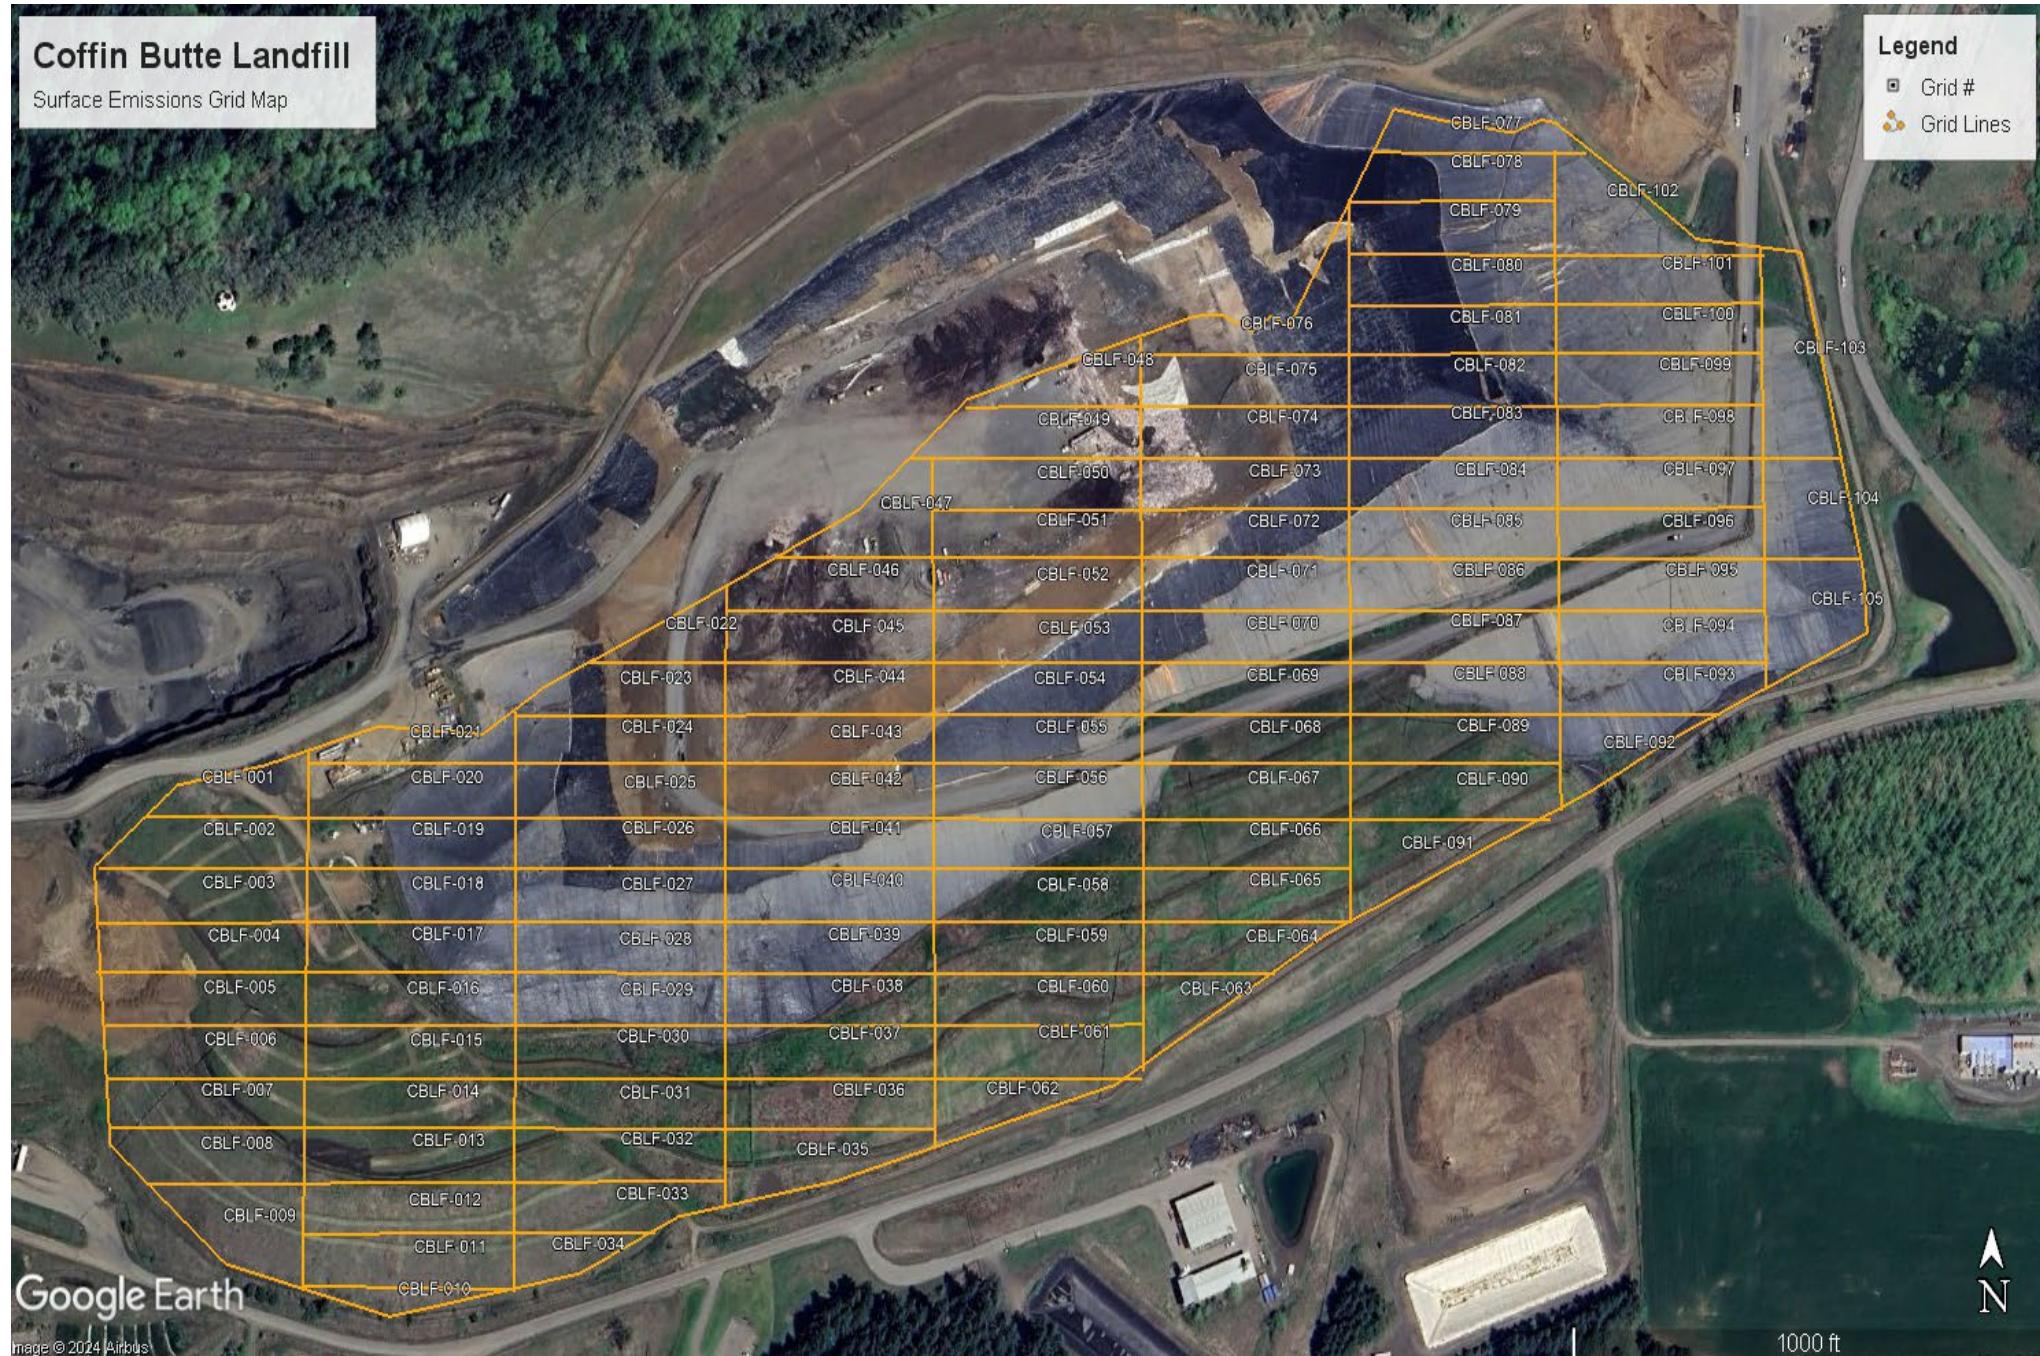
Attachment 2

Surface Emissions Monitoring Site Grid Map
Coffin Butte Landfill, Corvallis, Oregon

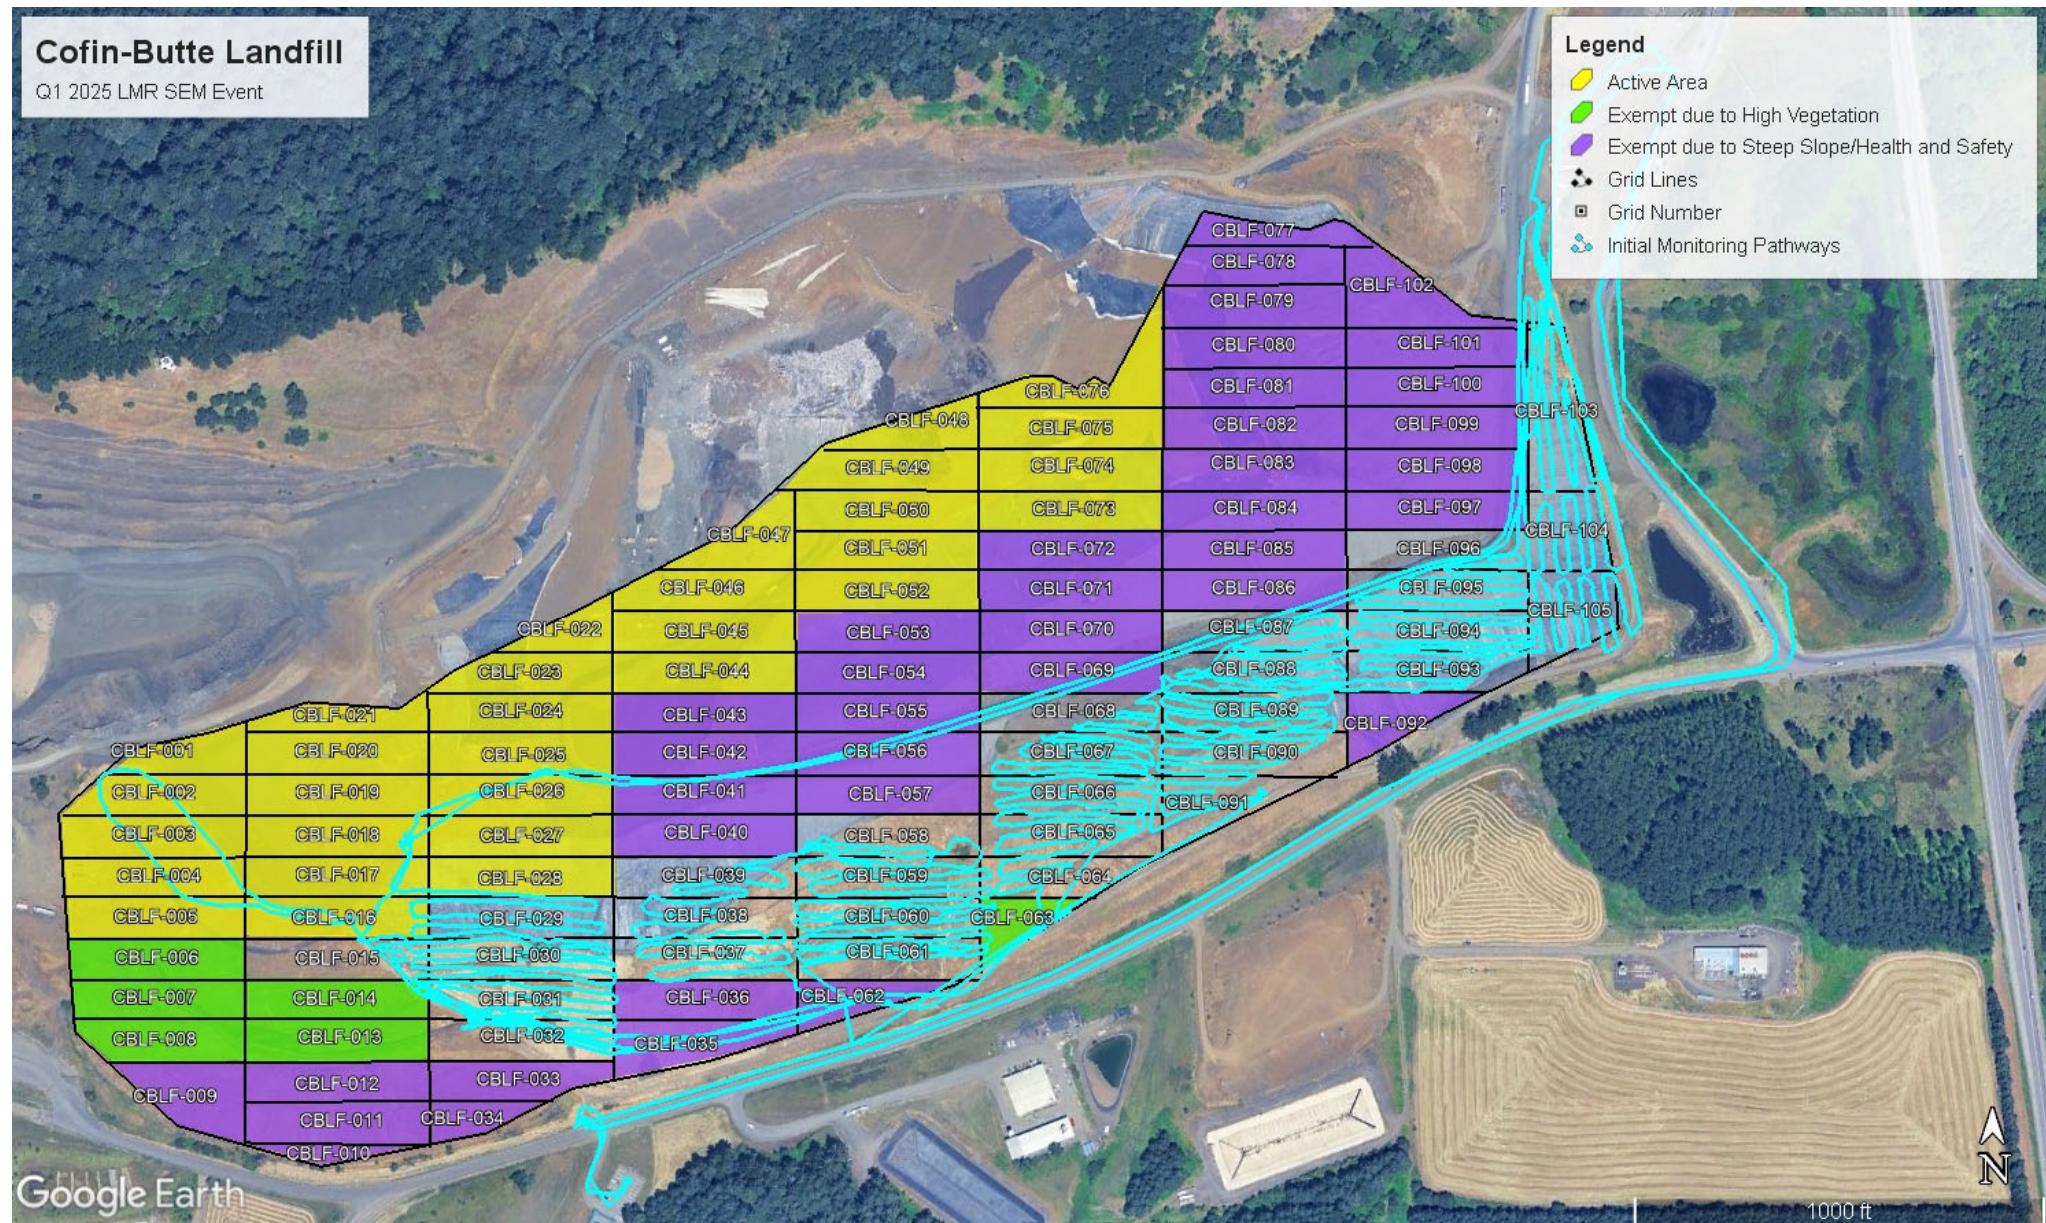
First Quarter 2025

Initial Surface Emissions Monitoring Pathway

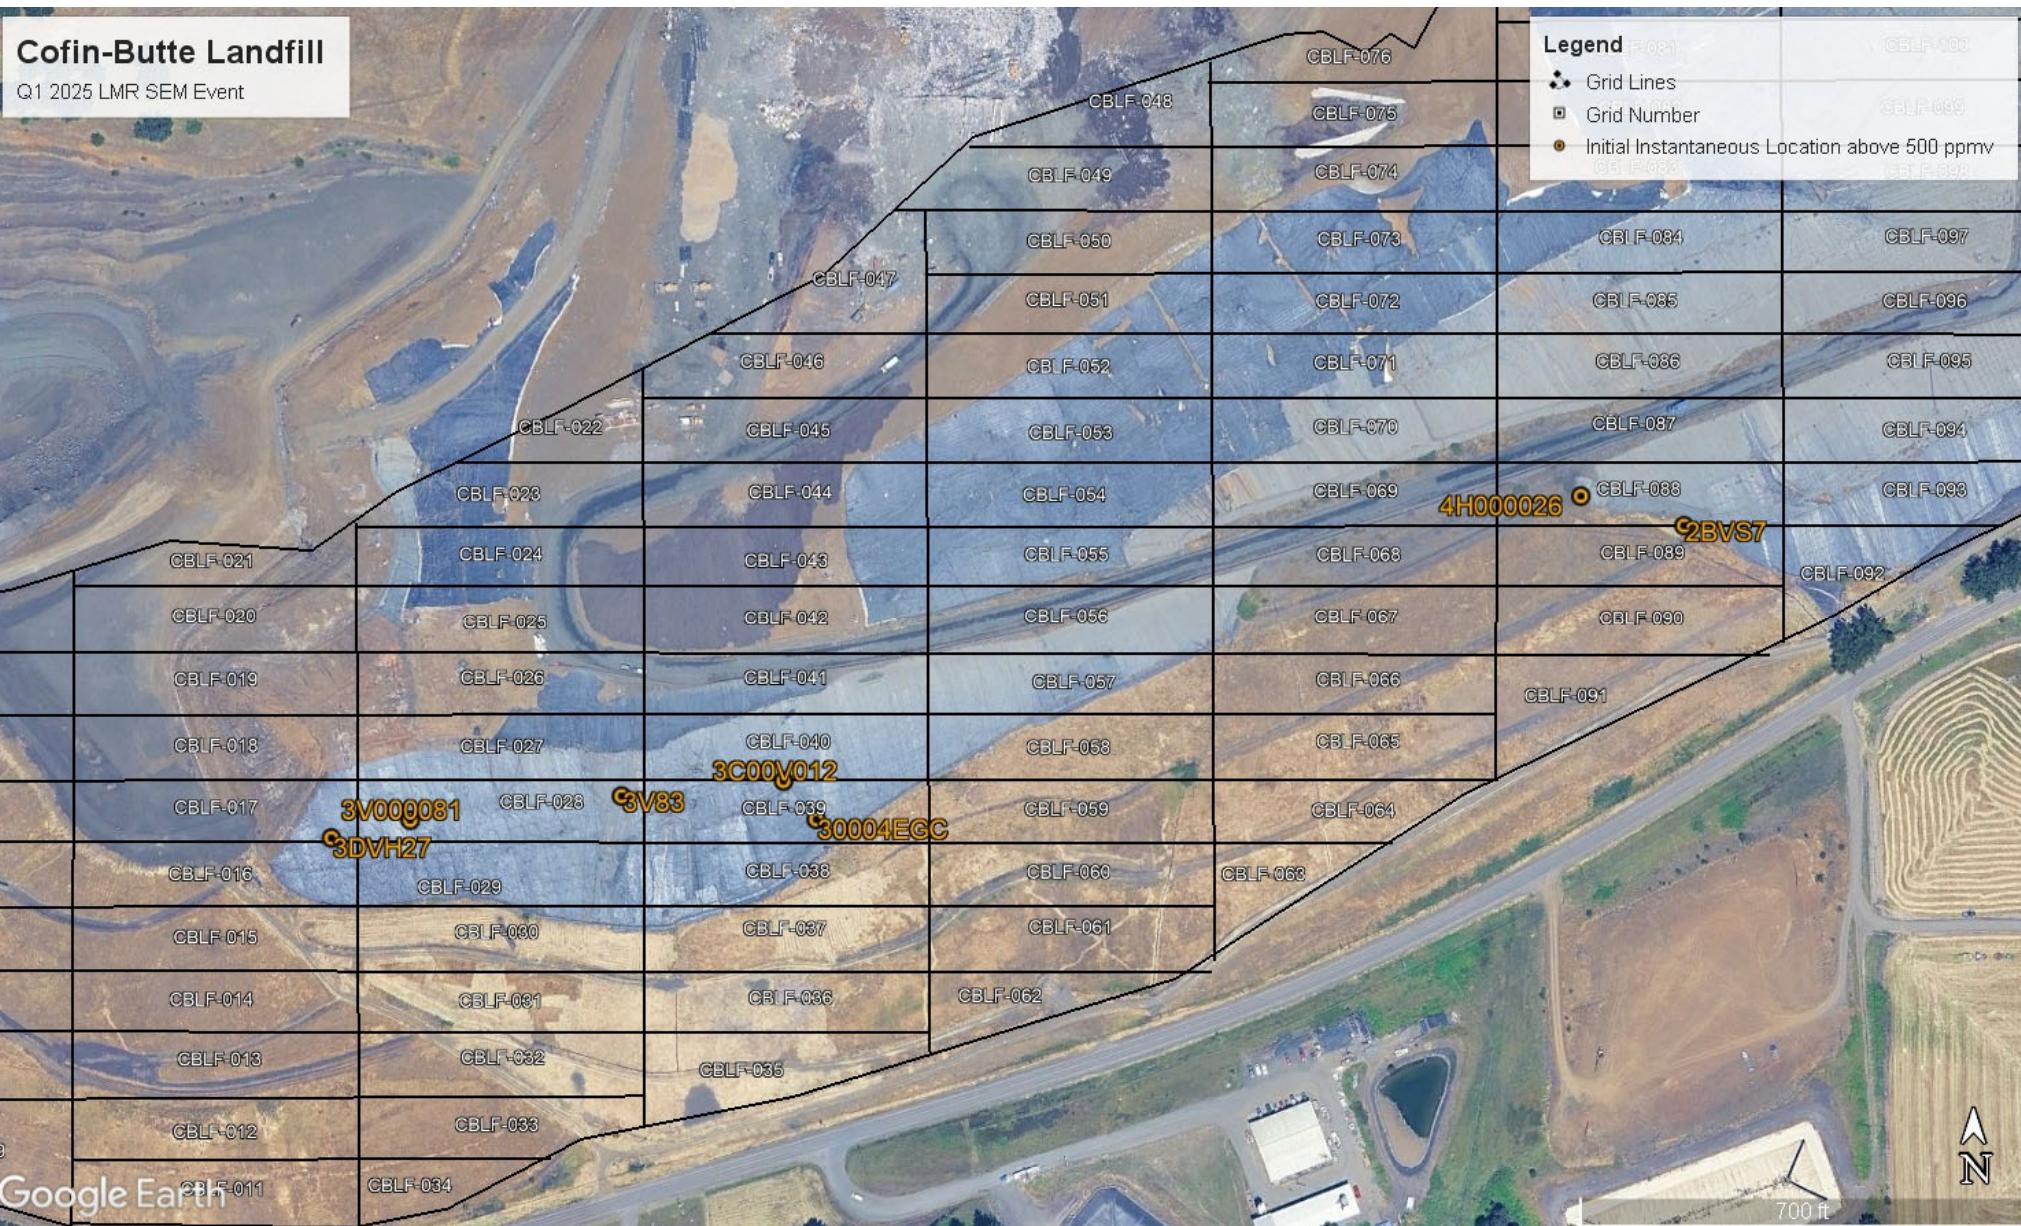
Attachment 3

First Quarter 2025
Initial Emissions Monitoring Results Greater than 500 ppmv
Coffin Butte Landfill, Corvallis, Oregon

No other exceedances of the 500 ppmv threshold were observed during the first quarter of 2025 monitoring.

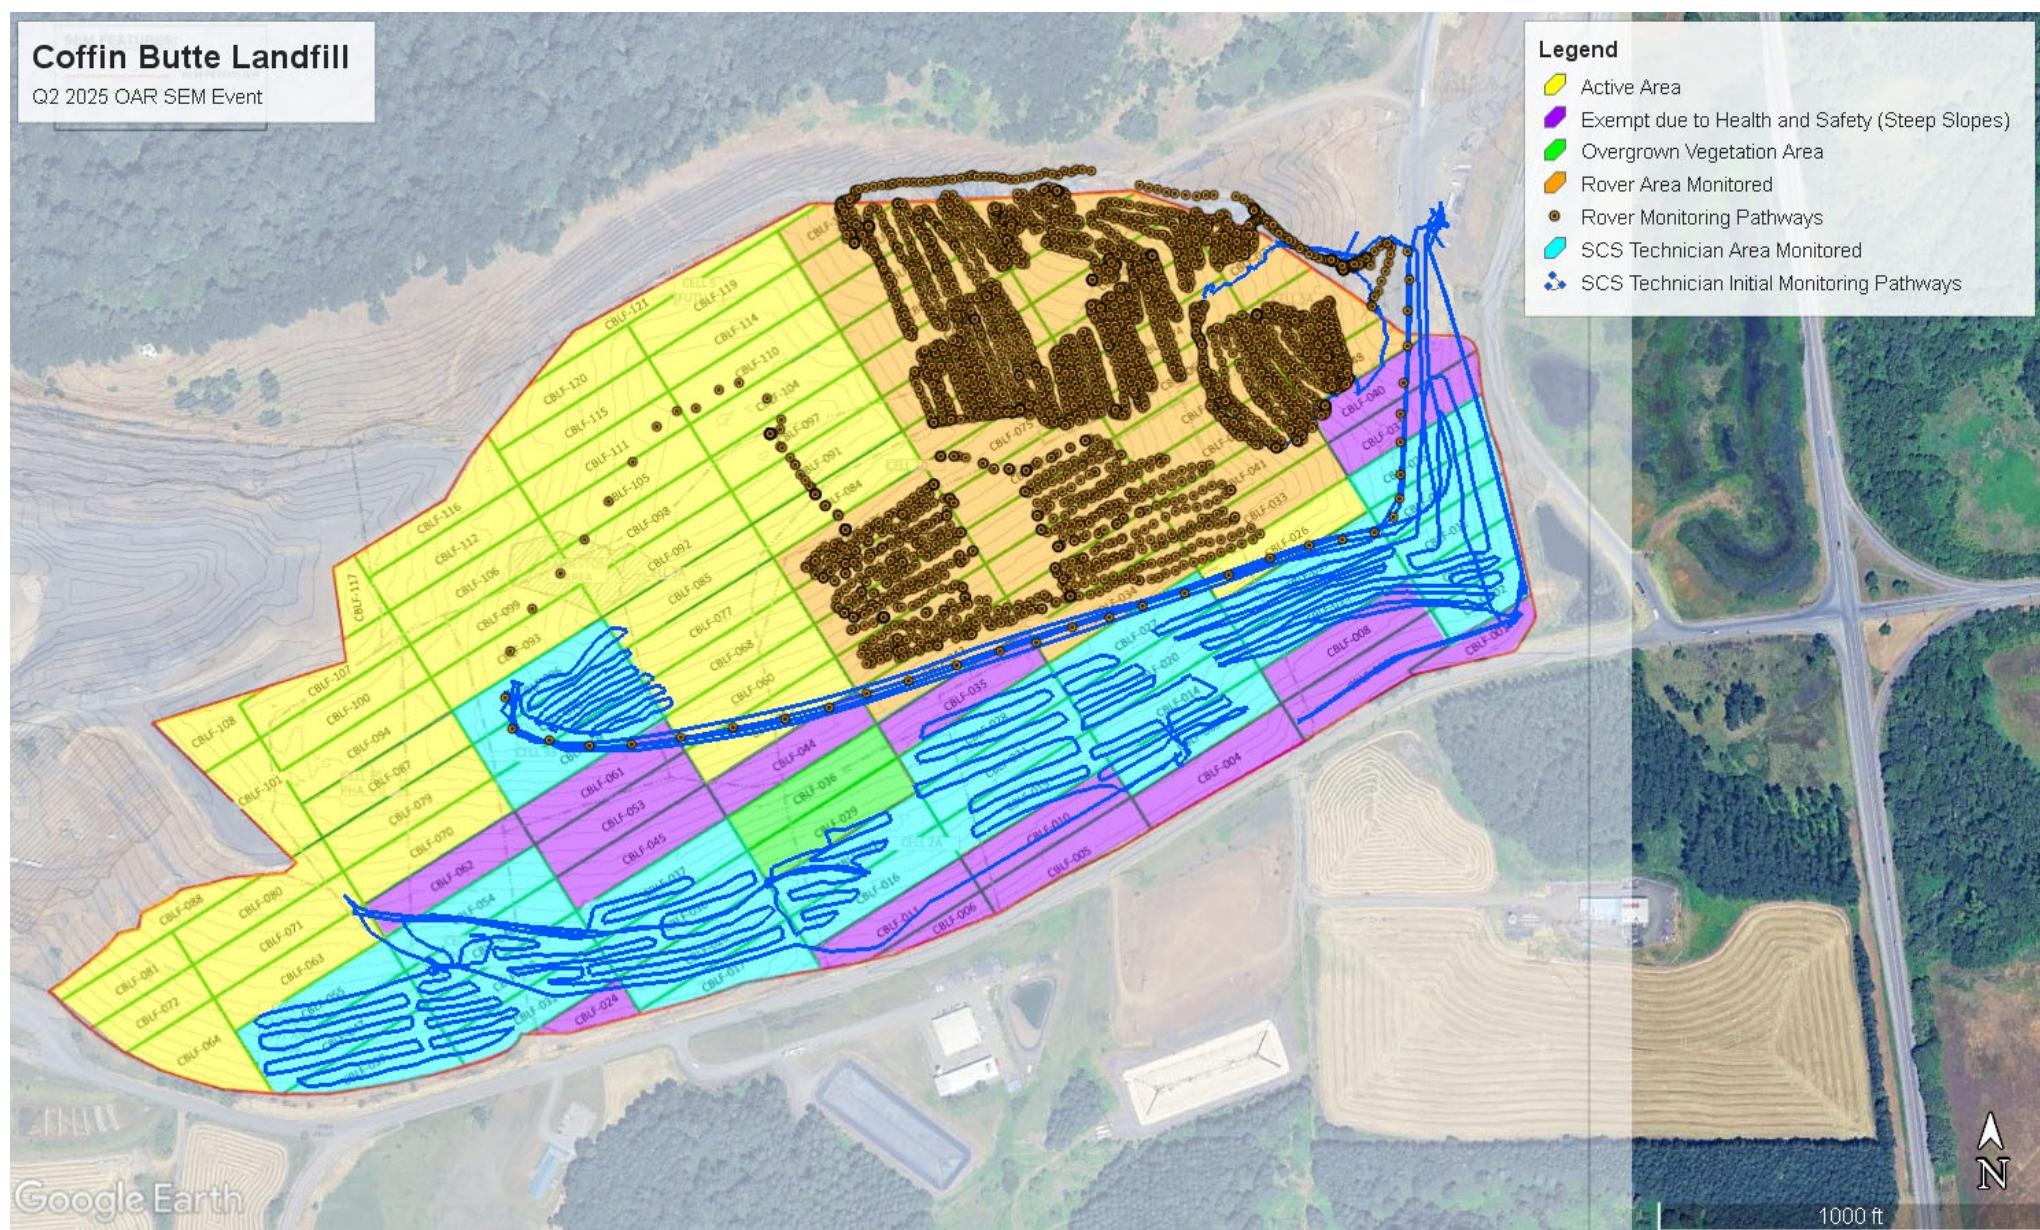
Attachment 3

A technology experiment data collection method was performed during the second quarter SEM event using a tank-Rover unit in areas with steep slopes and side slopes covered in plastic deemed unsafe for field staff. The intent of the Drone/Rover monitoring is to maximize safety on integrated grid paths covered in plastic.

- Active Area
- Exempt due to Health and Safety (Steep Slopes)
- Overgrown Vegetation Area
- Rover Area Monitored
- Rover Monitoring Pathways
- SCS Technician Area Monitored
- SCS Technician Initial Monitoring Pathways

**Second Quarter 2025
Initial Surface Emissions Monitoring Pathway
Coffin Butte Landfill, Corvallis, Oregon**

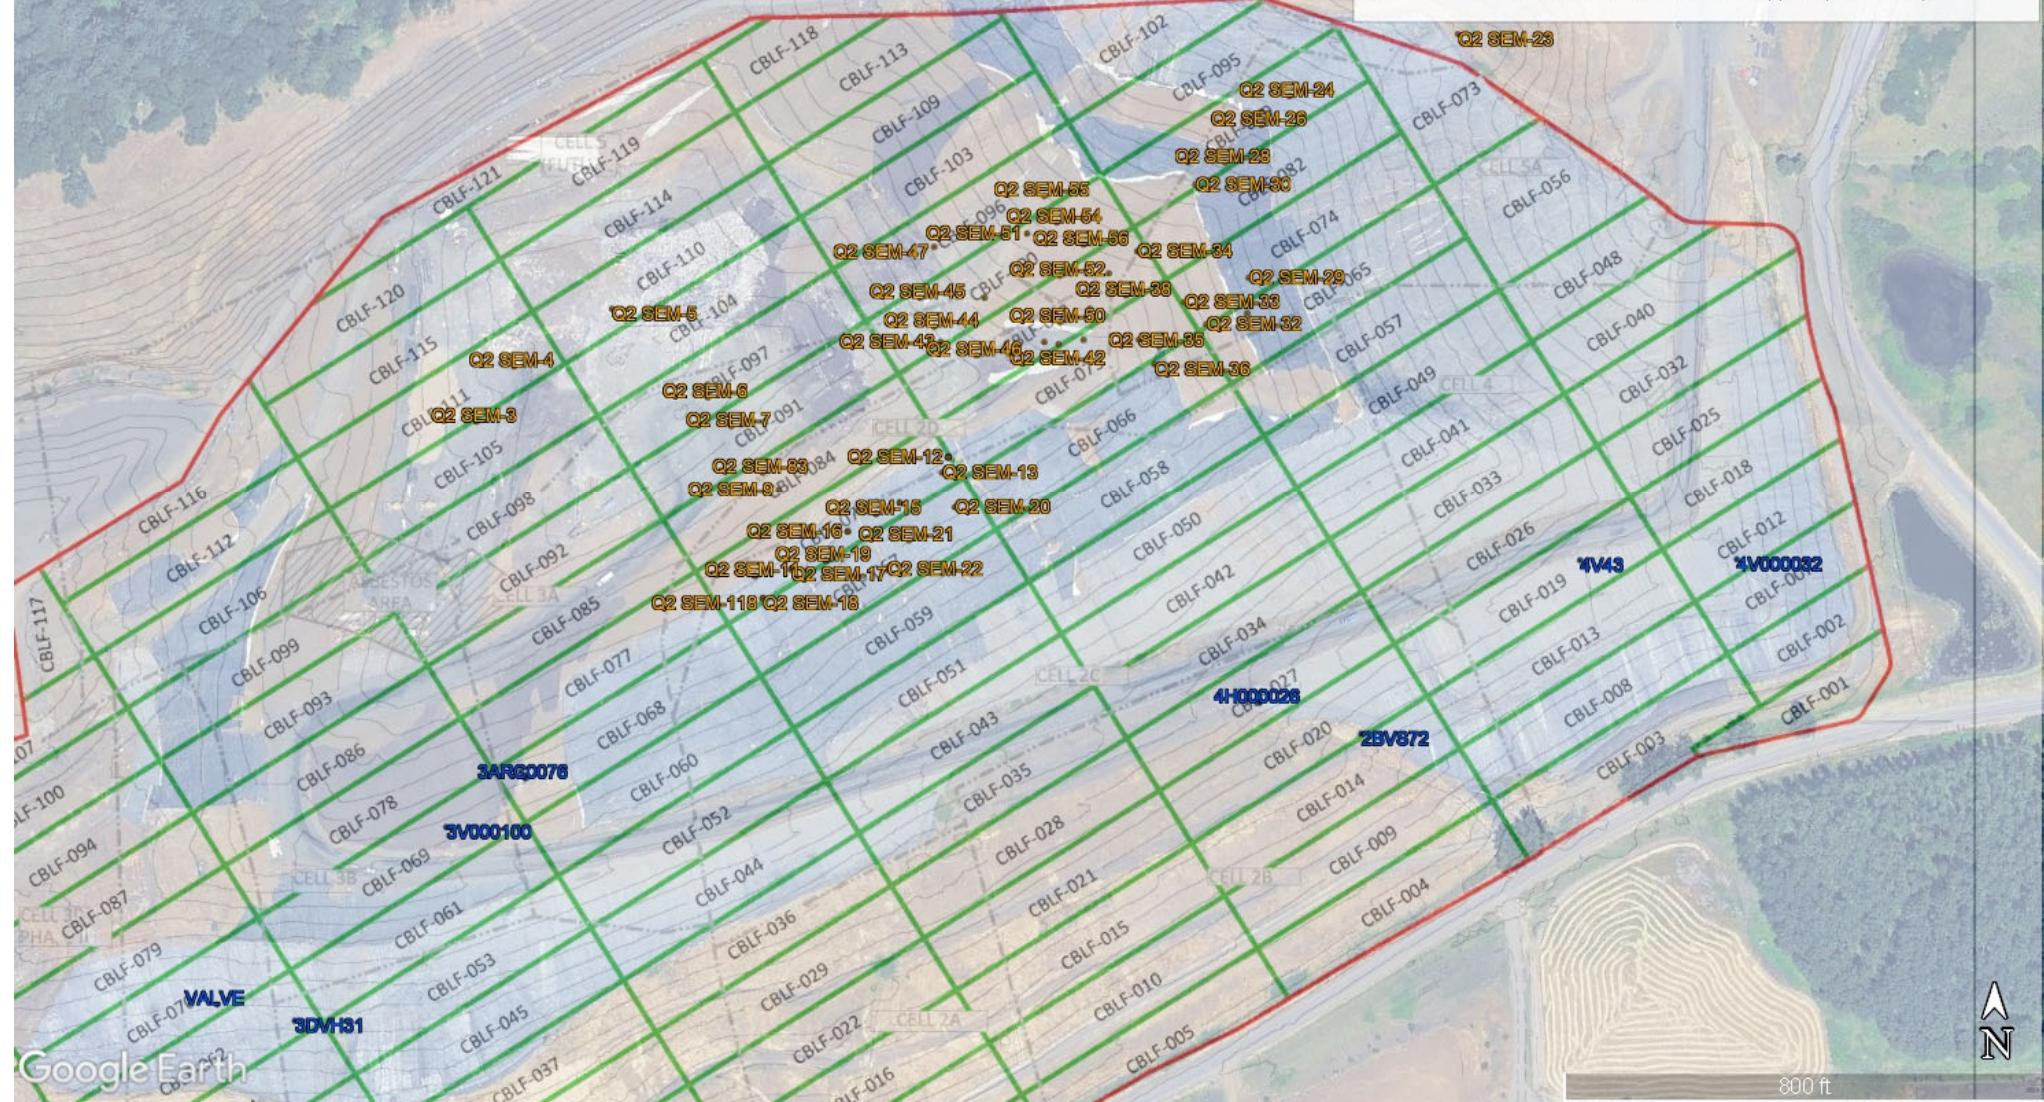
- Initial Instantaneous Location above 500 ppmv (from field technician)
- Initial Instantaneous Location above 500 ppmv (from rover)

Second Quarter 2025
Initial Emissions Monitoring Results Greater than 500 ppmv
Coffin Butte Landfill, Corvallis, Oregon

No other exceedances of the 500 ppmv threshold were observed during the second quarter of 2025 monitoring.

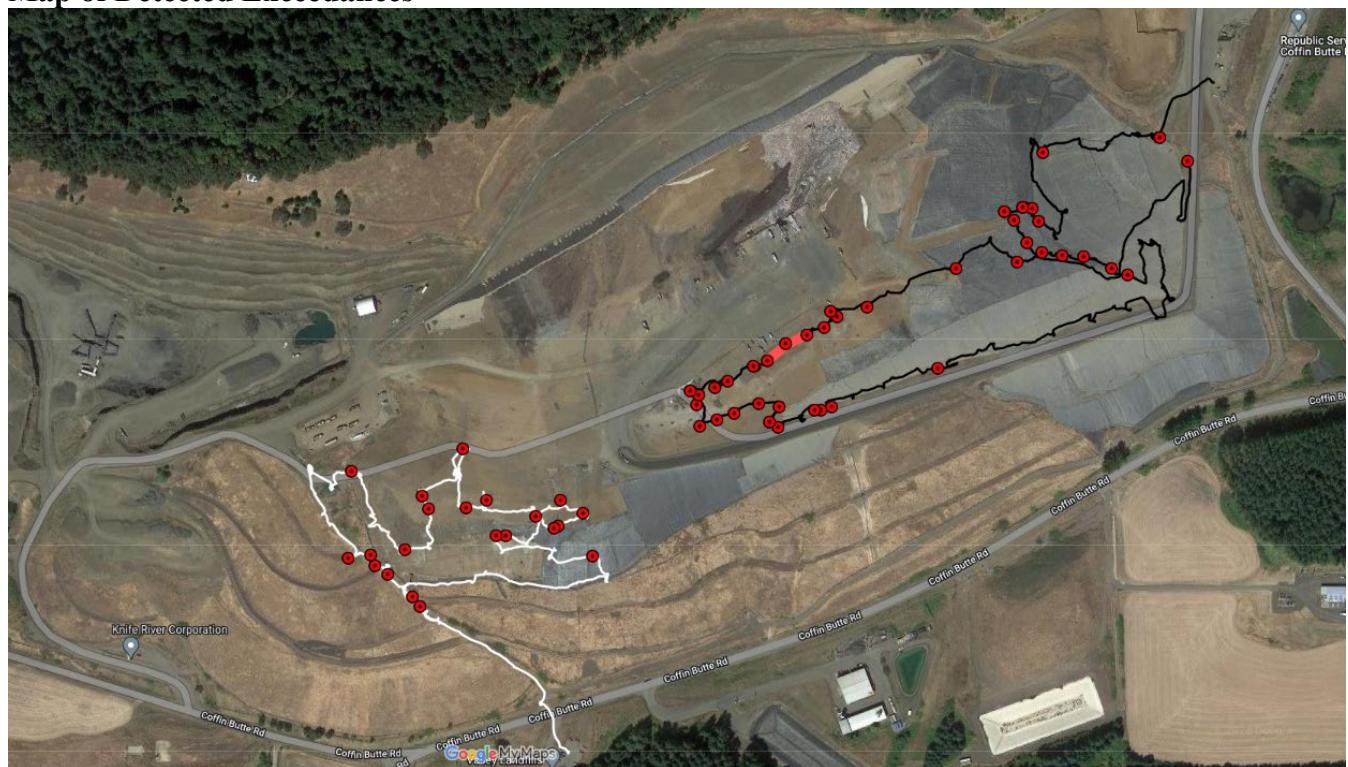
Map of Detected Exceedances

SEM exceedance locations plotted over Google Maps satellite imagery. Approximate monitoring paths included, derived from GPS data. Morning path shown in white, afternoon in black. Line of continuous exceedance at every tarp hole between flags 52 and 54 is highlighted in red.

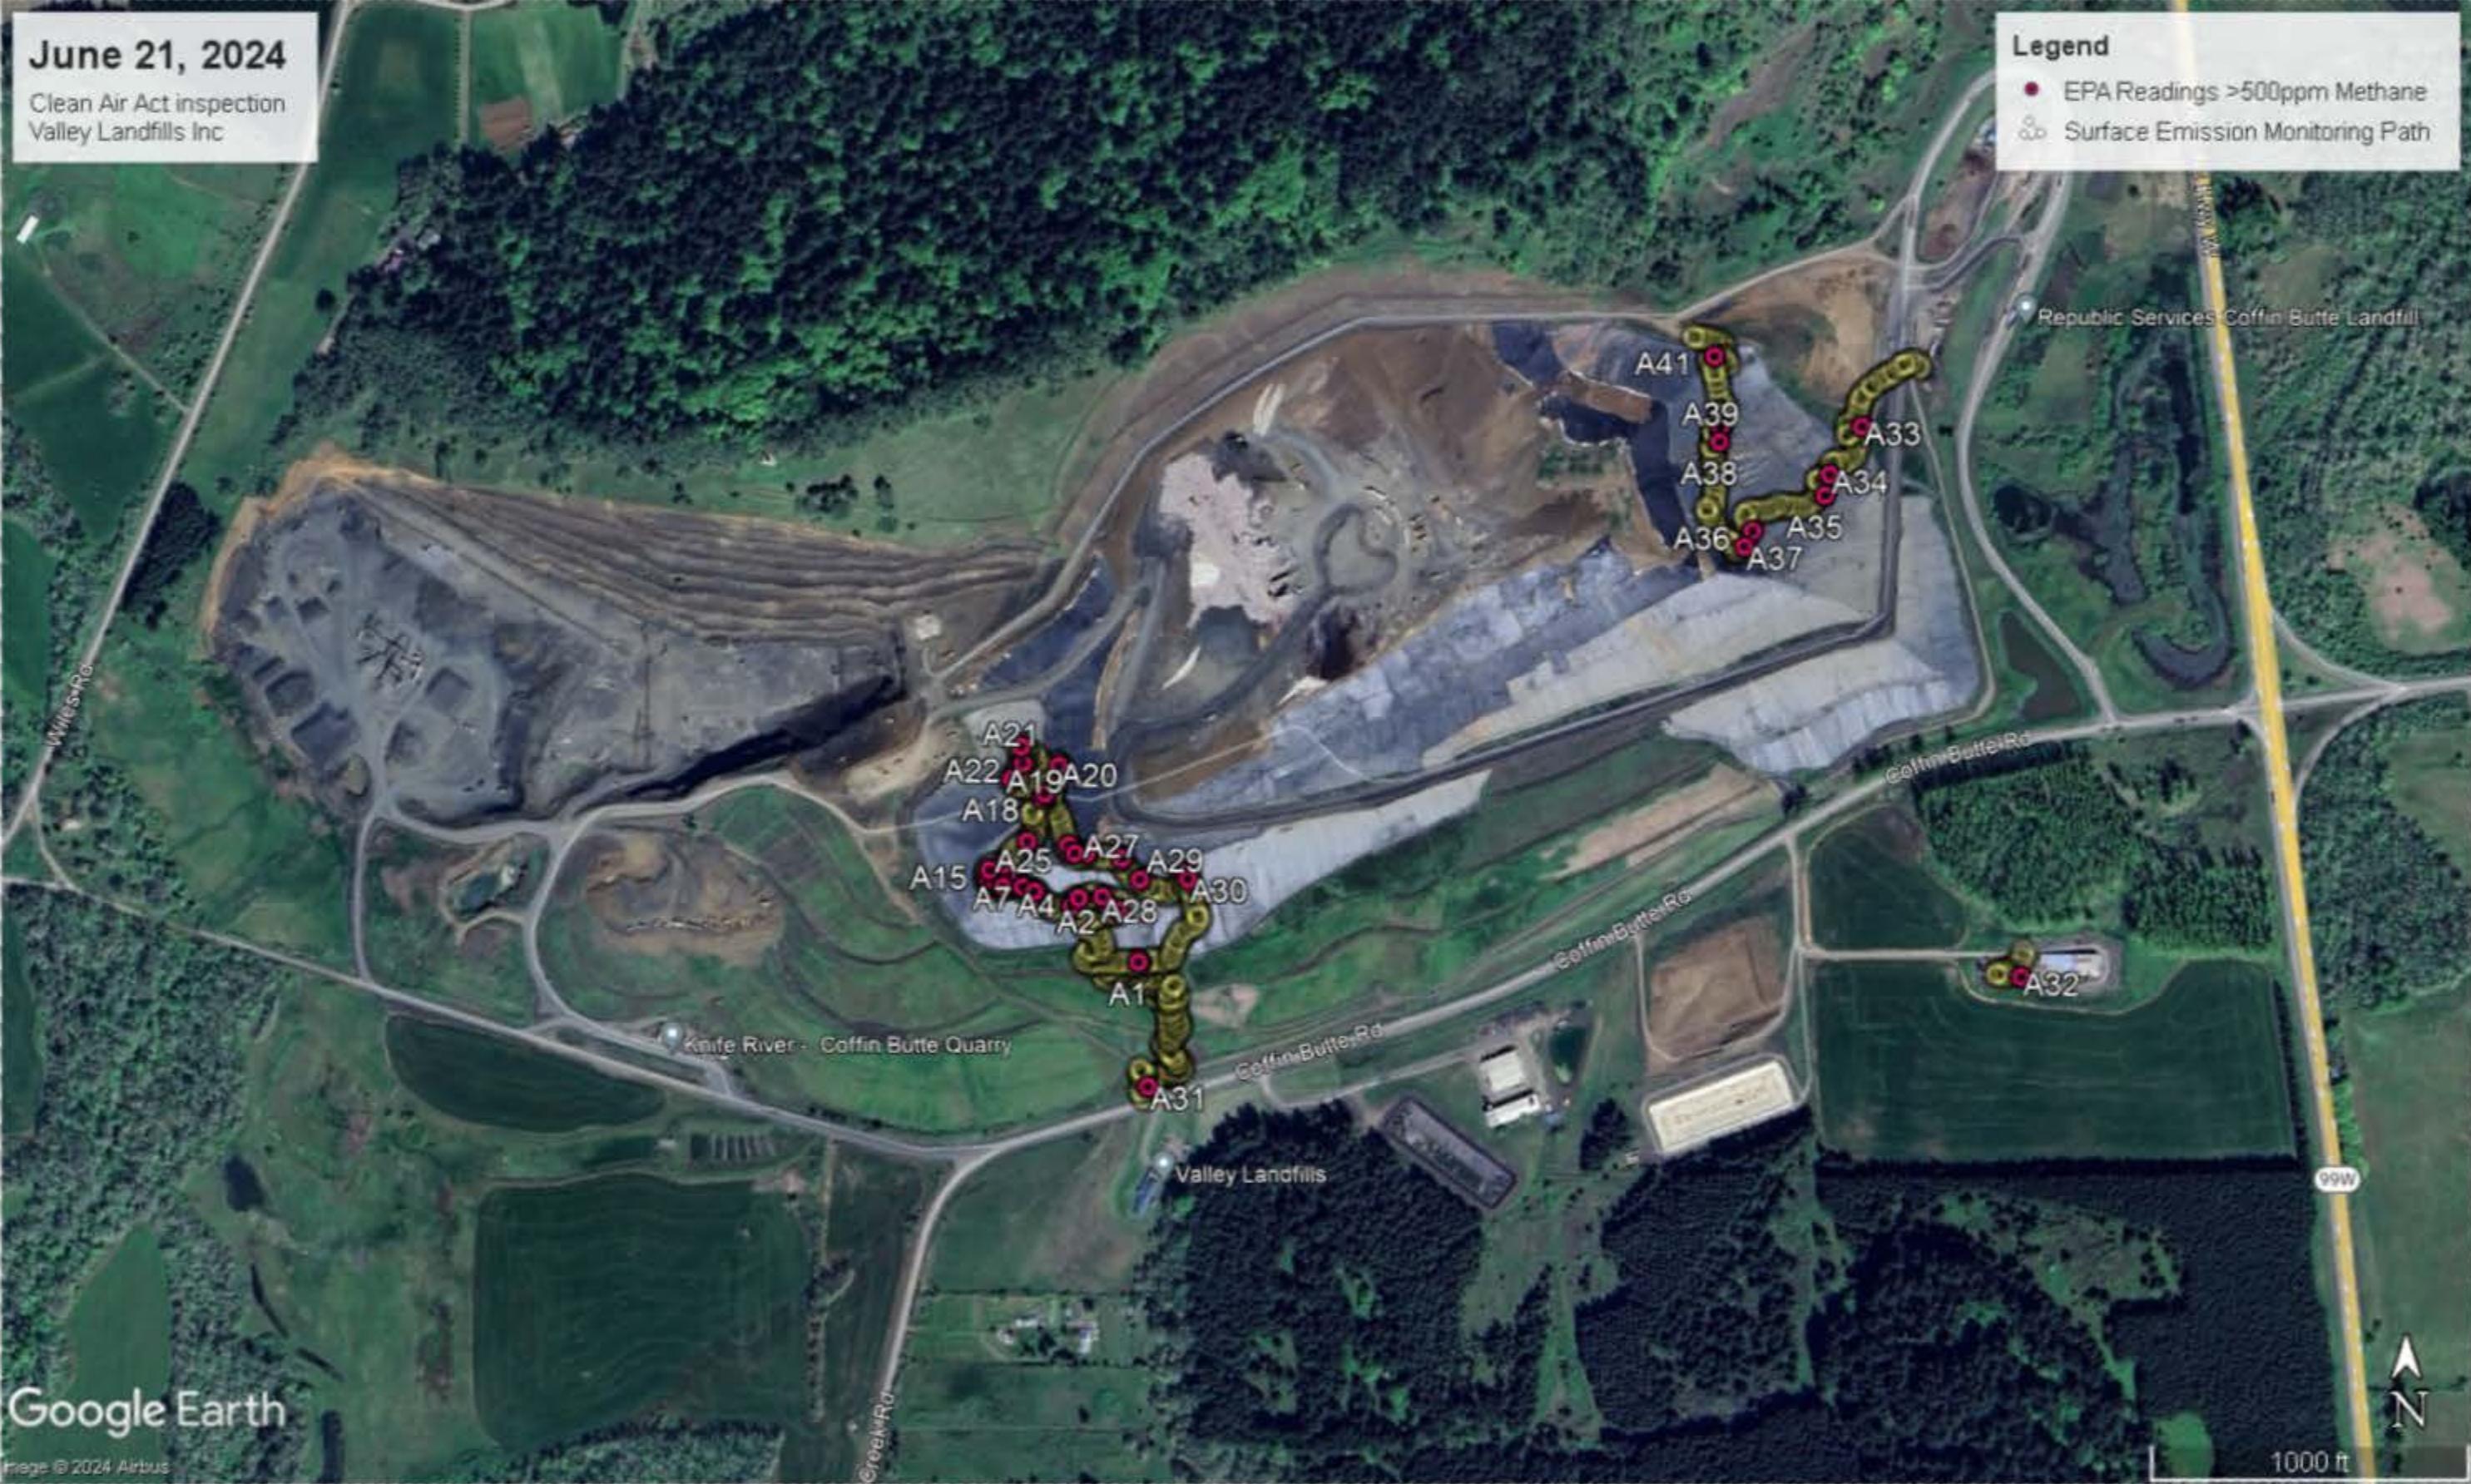
- EPA Readings >500ppm Methane
- Surface Emission Monitoring Path

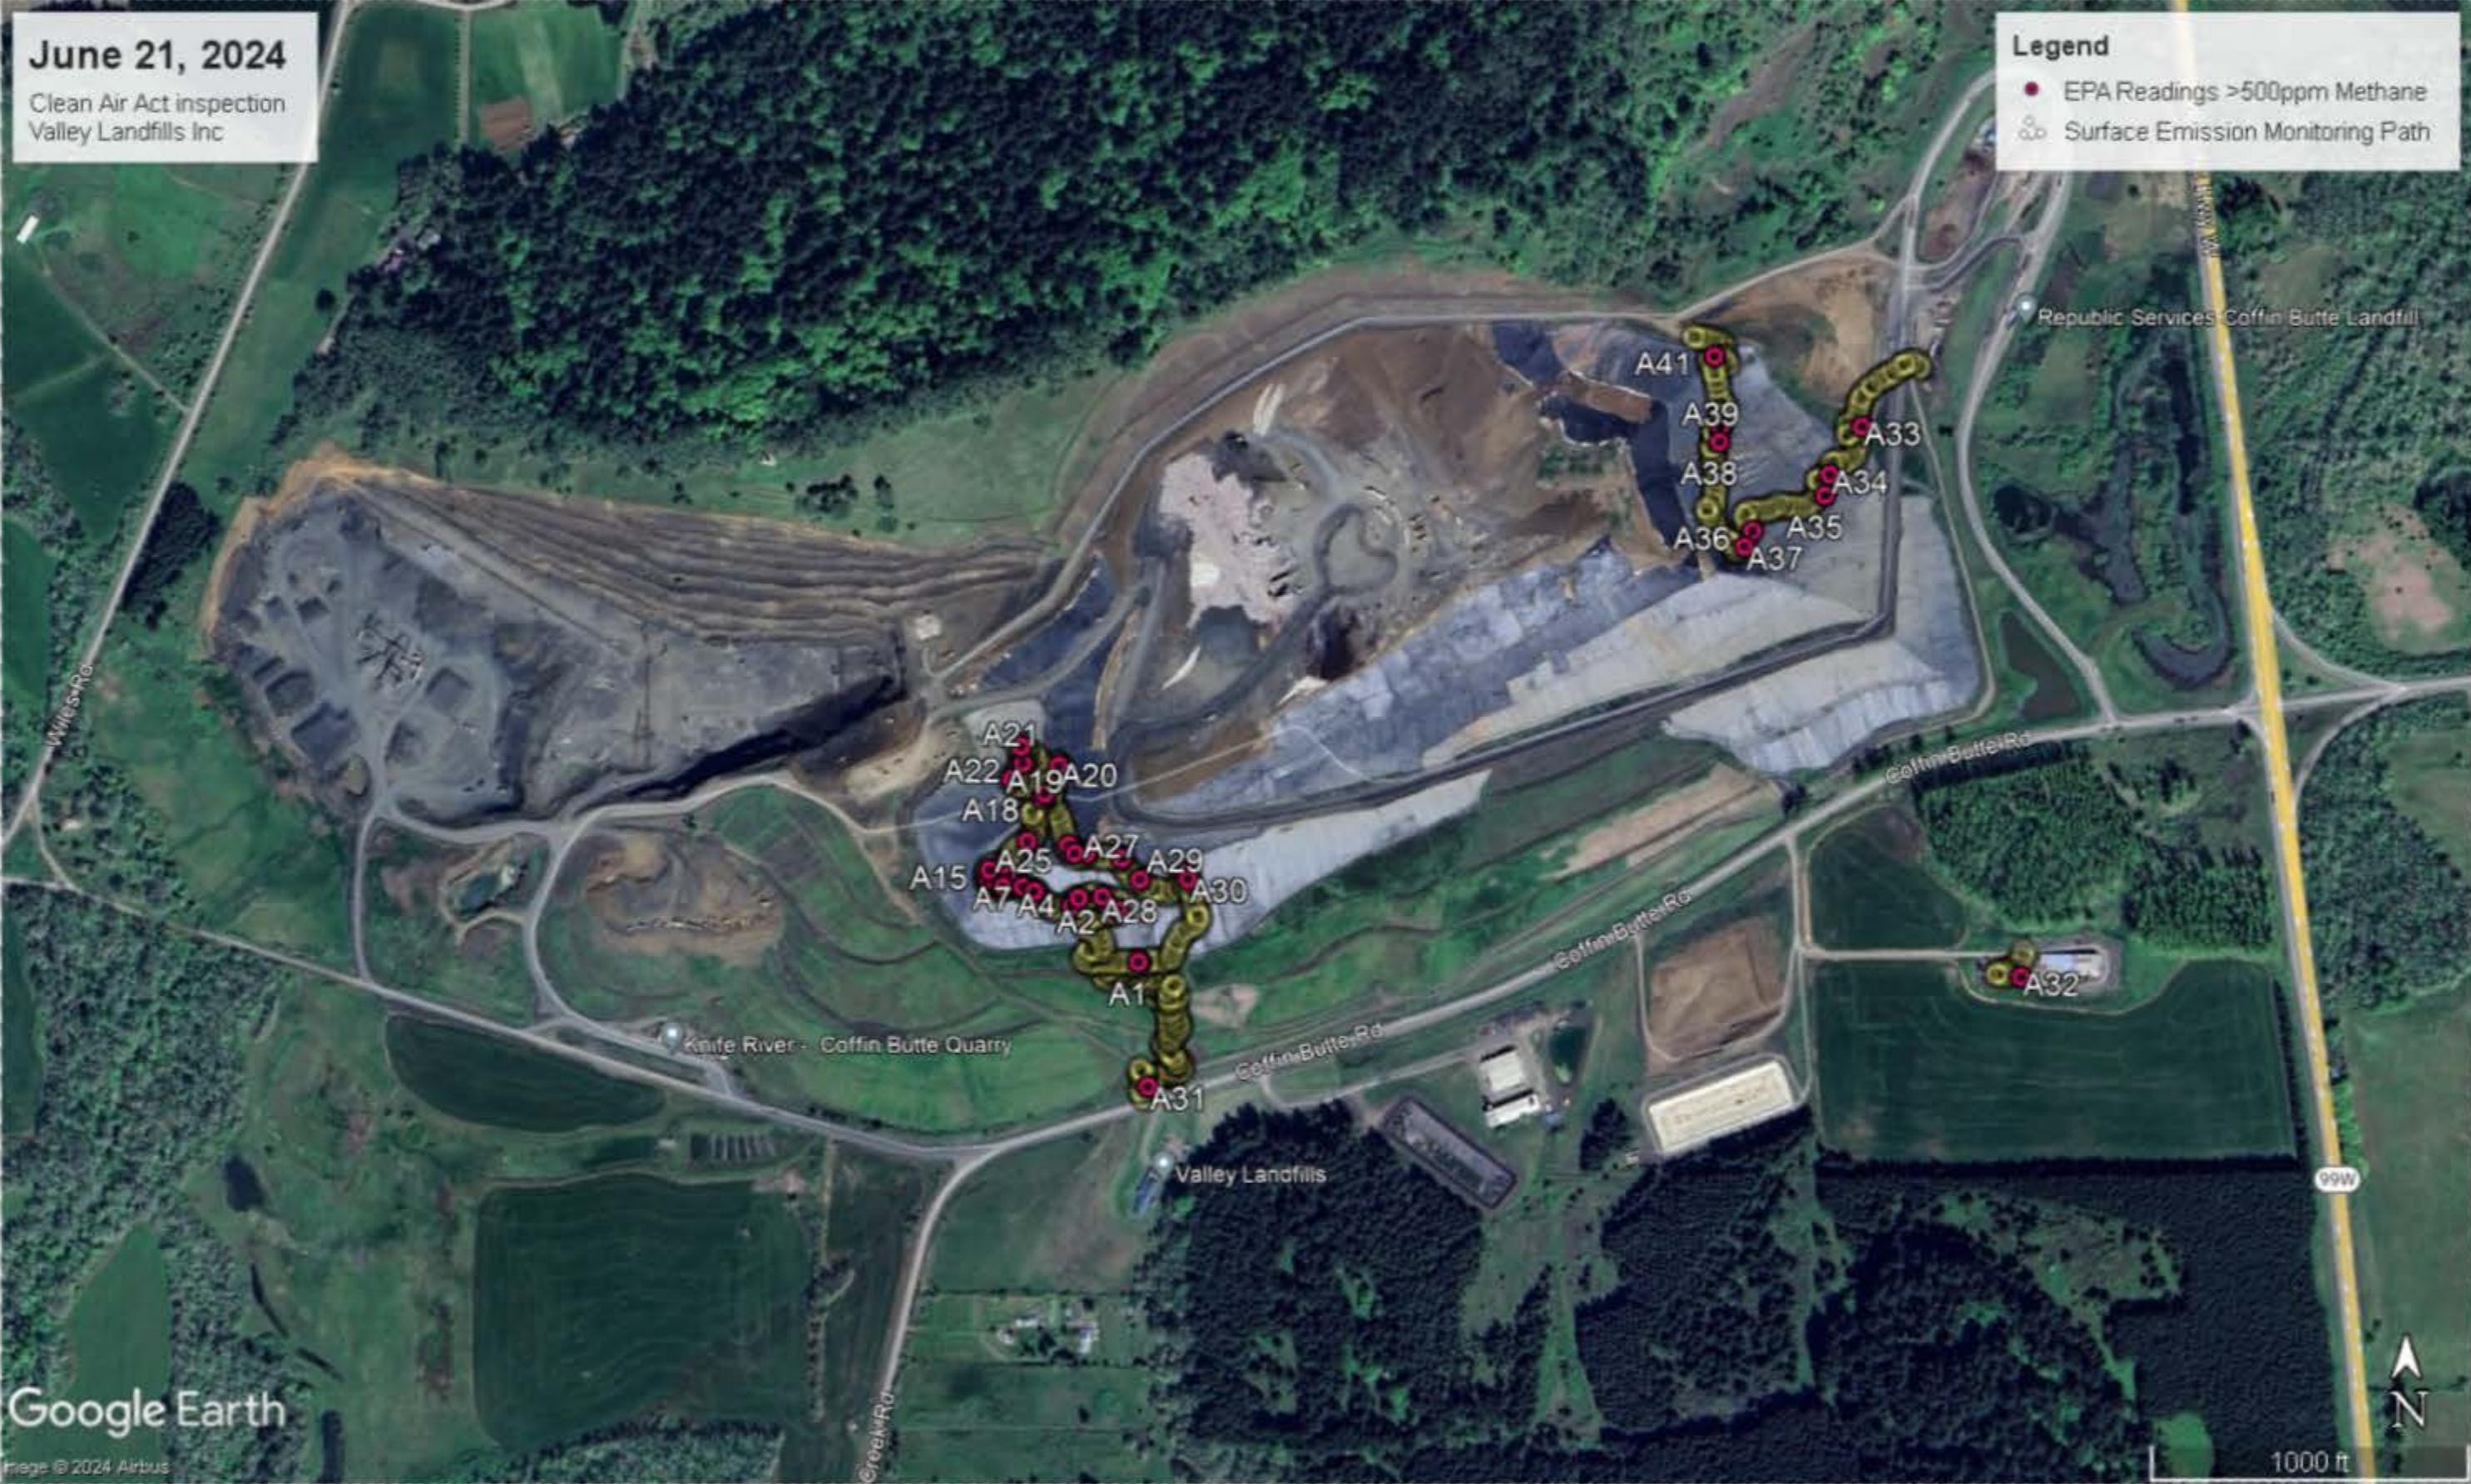
- EPA Readings >500ppm Methane
- Surface Emission Monitoring Path
