# PHASE II GEOTECHNICAL EXPLORATION REPORT COFFIN BUTTE LANDFILL SOUTH EXPANSION AREA 28972 COFFIN BUTTE ROAD CORVALLIS, OREGON

July 15, 2024

Wallace Group Project No. 21129 (1)

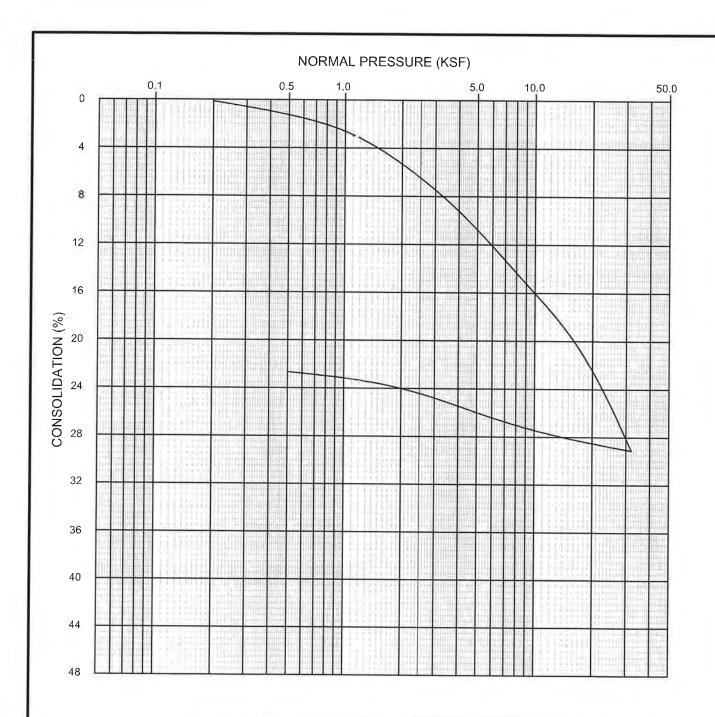
#### Sample ID: BH-11 ST1-S6 @ 12.0-14.0 Ft.

One Dimensional Cor (ASTM D		
Test	Initial Con	ditions	Final Conditions
Moisture Content, (%)	75.6		60.1
Dry Unit Weight, (pcf)	52.3		65.7
Height of Specimen, (inches)	0.75		0.58
Load (ksf)	Dial Reading (inches)	Load (ksf)	Dial Reading (inches)
Initial	0.0008	16.0	0.1571
0.5	0.0094	32.0	0.2177
1.0	0.0199	8.0	0.2026
2.0	0.0401	2.0	0.1829
4.0	0.0694	0.5	0.1700
8.0	0.1076

## CONSOLIDATION TEST RESULTS - ASTM D2435

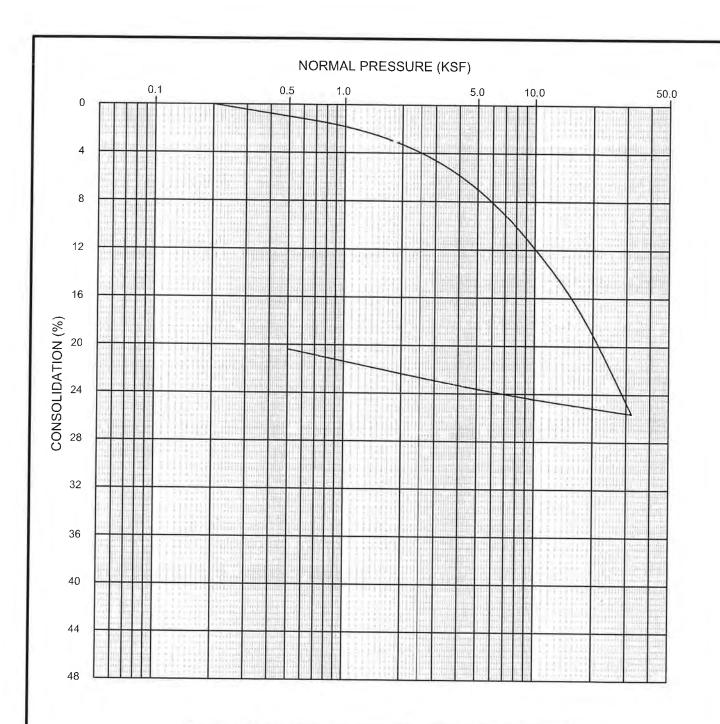
#### Sample ID: BH-12A ST-2 @ 10.0-12.0 Ft.

One Dimensional Cor (ASTM D		
Test	Initial Con-	ditions	Final Conditions
Moisture Content, (%)	63.9		56.9
Dry Unit Weight, (pcf)	58.1		69.4
Height of Specimen, (inches)	0.75	0.75	
Load (ksf)	Dial Reading (inches)	Load (ksf)	Dial Reading (inches)
Initial	0.0000	16.0	0.1235
0.5	0.0075	32.0	0.1920
1.0	0.0140	8.0	0.1815
2.0	0.0245	2.0	0.1680
4.0	0.0435	0.5	0.1535
8.0	0.0760

SAMPLE LOCATION	NORMAL PRESSURE AT SATURATION (KSF)
BH-12A ST-2 @ 10.0 - 12.0 FT.	0.50
	LOCATION BH-12A ST-2

## CONSOLIDATION TEST RESULTS - ASTM D2435

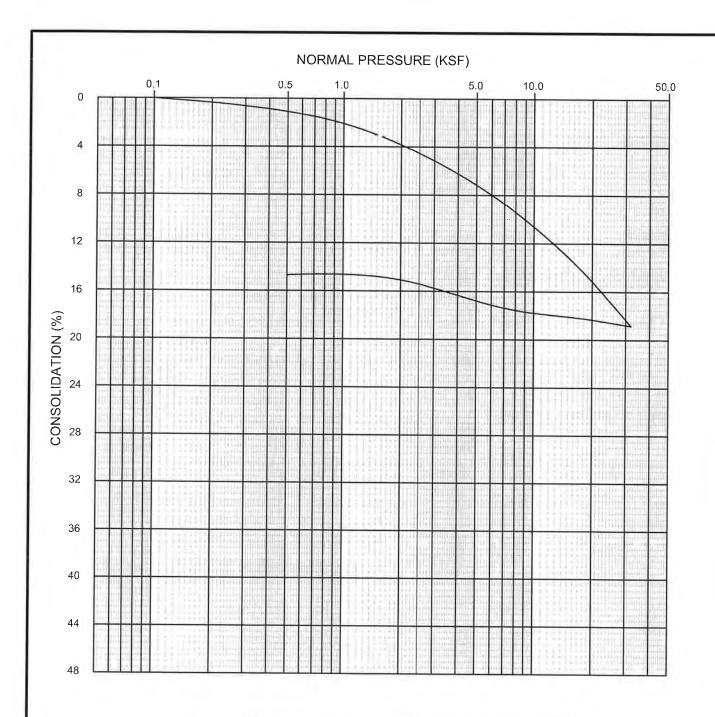
#### Sample ID: BH-12A ST-3 @ 20.0-22.0 Ft.

One Dimensional Cor (ASTM D		
Test	Initial Con	ditions	Final Conditions
Moisture Content, (%)	64.9		47.7
Dry Unit Weight, (pcf)	62.5	5	74.9
Height of Specimen, (inches)	1.0	1.0	
Load (ksf)	Dial Reading (inches)	Load (ksf)	Dial Reading (inches)
Initial	-0.0010	16.0	0.1354
0.5	0.0107	32.0	0.1880
1.0	0.0207	8.0	0.1753
2.0	0.0380	2.0	0.1509
4.0	0.0623	0.5	0.1464
8.0	0.0944

SYMBOL	SAMPLE LOCATION	NORMAL PRESSURE AT SATURATION (KSF)
	BH-12A ST-3 @ 20.0 - 22.0 FT	0.50

### CONSOLIDATION TEST RESULTS - ASTM D2435

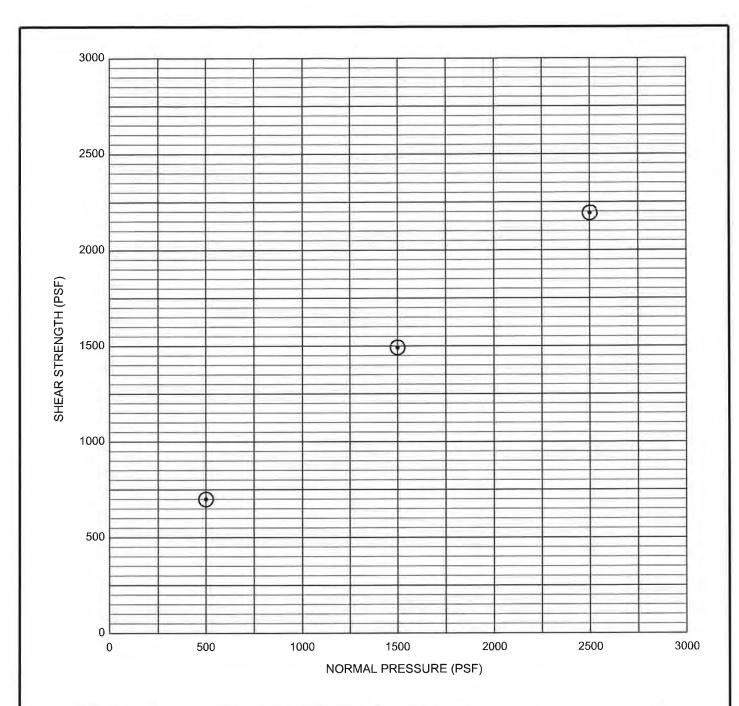
Direct Shear Test of Soils Under Consolidated Drained Conditions – Sample Data (ASTM D3080)					
Test	500psf Normal Load Initial Conditions	1500psf Normal Load Initial Conditions	2500psf Normal Load Initial Conditions		
Moisture Content, (%)	55.9	57.7	63.1		
Dry Unit Weight, (pcf)	62.2	59.9	59.6		
Peak Shear Strength, (psf)	567	1340	2164

SYMBOL	SAMPLE LOCATION	COHESION (psf)	FRICTION ANGLE	REMARKS
•	BH-7, ST-1 @ 10.0 - 12.0 FT.	1		SATURATED; UNDISTURBED

## DIRECT SHEAR TEST RESULTS - ASTM D3080

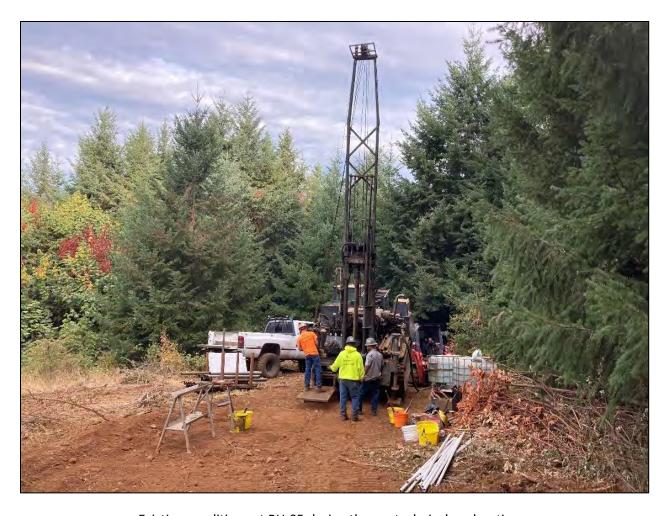
Existing conditions at BH-05 during the geotechnical exploration.

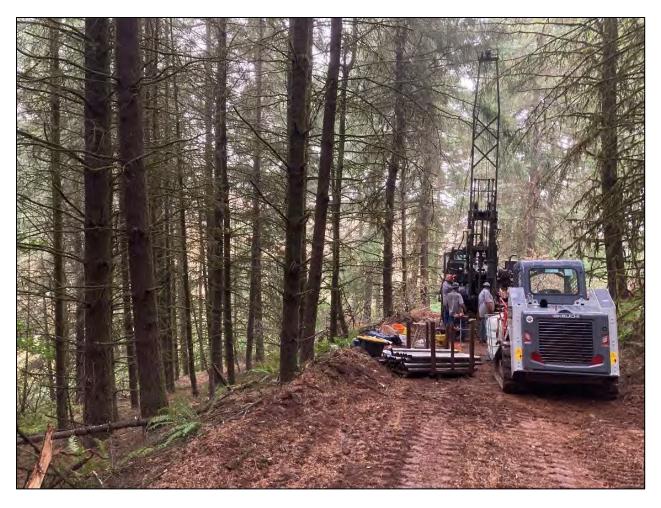
Drilling performed with track-mounted CME rig, operated by Western States Drilling, on February 16 through 18, 2021 and HazTech Drilling on November 8 through 16, 2022. Note the skid steer and cleared road required for site access.

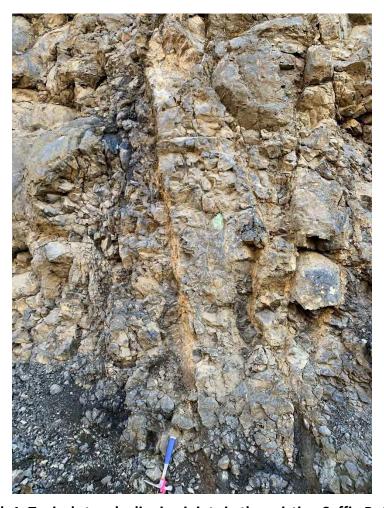
Photograph 1. Typical steeply dipping joints in the existing Coffin Butte quarry.

In general, the discontinuities mapped were very persistent (greater than 30 feet in trace length) and typically filled with clay, sand, and gravel sized particles. The infilling was up to two inches in thickness. See Photographs 1 and 2 for typical exposures of mapped discontinuities. Conchoidal fractures associated with the basalt exposed in the rock quarry were not mapped.

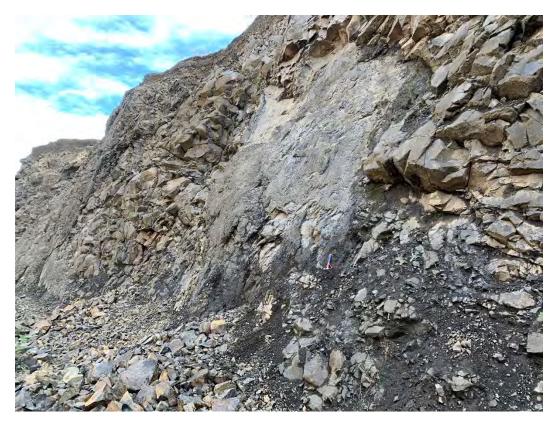
Photograph 2. Steeply dipping joint trending subparallel to an existing cut face.

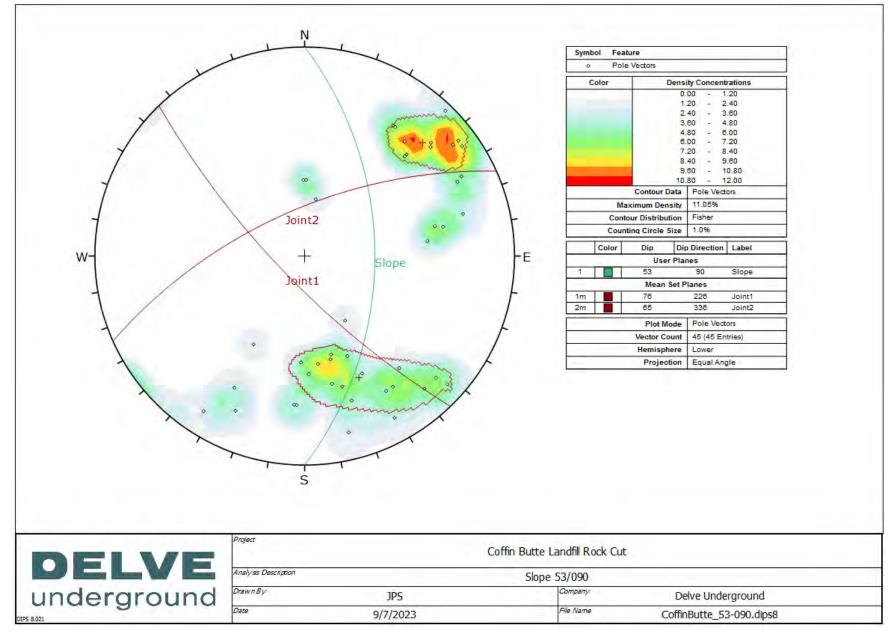
# Slope: 53/090 – Stereonet

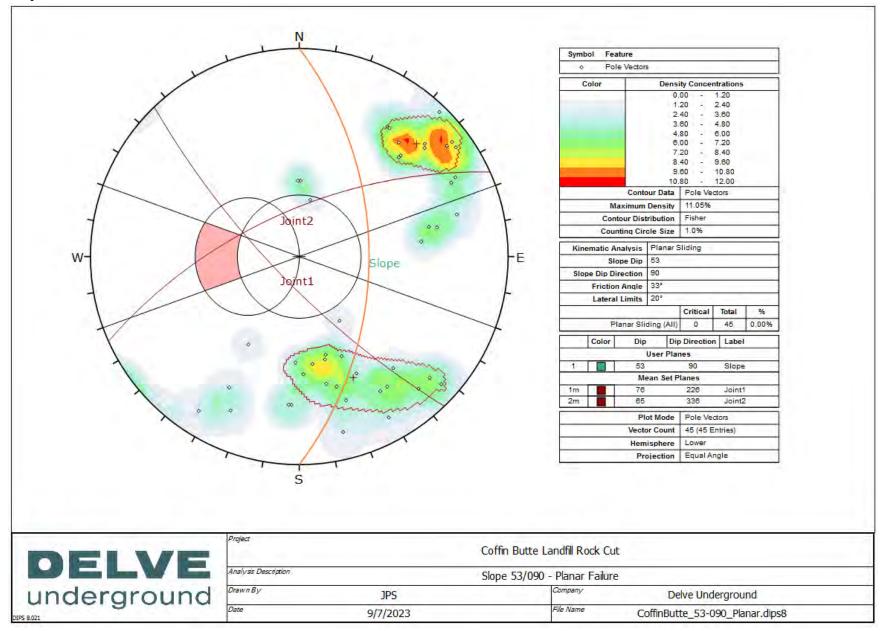
# Slope: 53/090 – Planar Failure

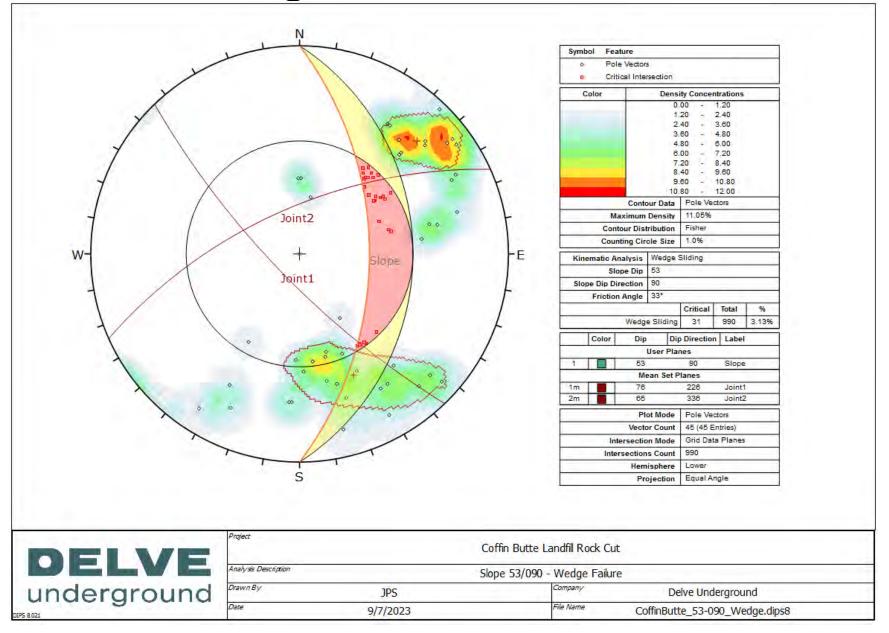
# Slope: 53/090 – Wedge Failure
